MAGISTRATES COURT of TASMANIA
CORONIAL DIVISION

**IN THE MATTER OF AN INQUEST
TOUCHING THE DEATH OF
LARRY PAUL KNIGHT**

**FINDINGS, RECOMMENDATIONS AND COMMENTS of Coroner Rod
Chandler following an inquest held in Launceston on 22 July to 25
September and 11 November 2008.**

26 February 2009

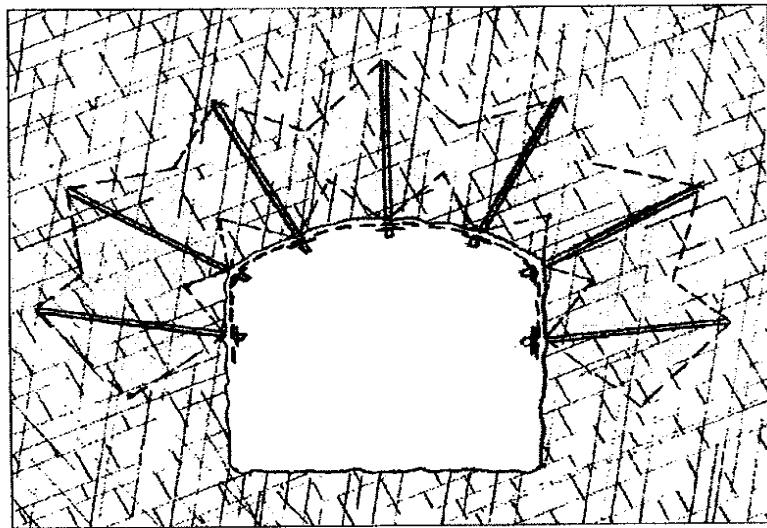
“The approach taken for the intensely jointed rock mass was to assume that the ground would behave as a beam a (sic) across its narrowest dimension. It was considered that the failure would be unlikely to be dominated by keystone wedges and that an unravelling mode of failure was more likely. Therefore the design endeavoured to support a mass of material equivalent to a parabolic arch of height equal to half the span.”

Fig. 10 shows in diagrammatic form an excavation supported by pattern bolting. It shows a zone of compressive strength in which interlocking of individual pieces is retained and a self-supporting arch is created.
