# Investigation Report

Fire and explosion on Longwall No 1 Tailgate  
at the Blakefield South Mine  
5 January 2011

Published report prepared by the  
Investigation Unit, Thornton

Report Date 8 May 2012

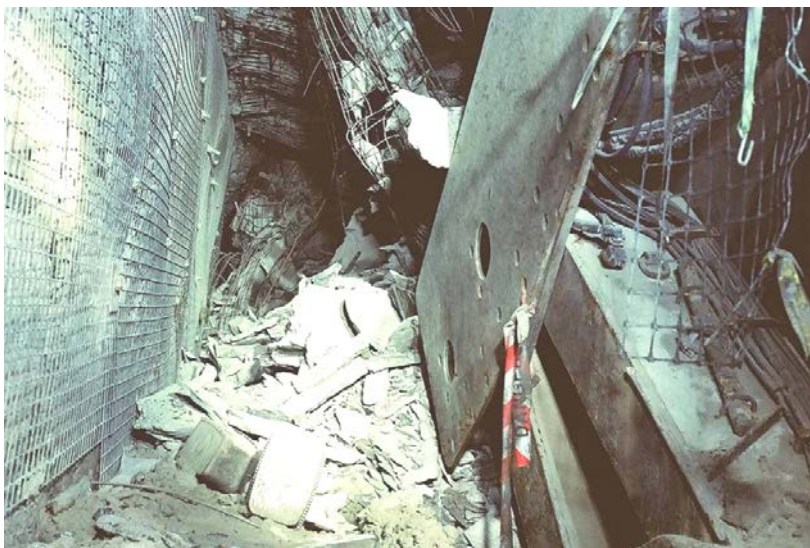
**Figure 19: Looking at the goaf between the chain pillar rib and chock 1 at the main gate**

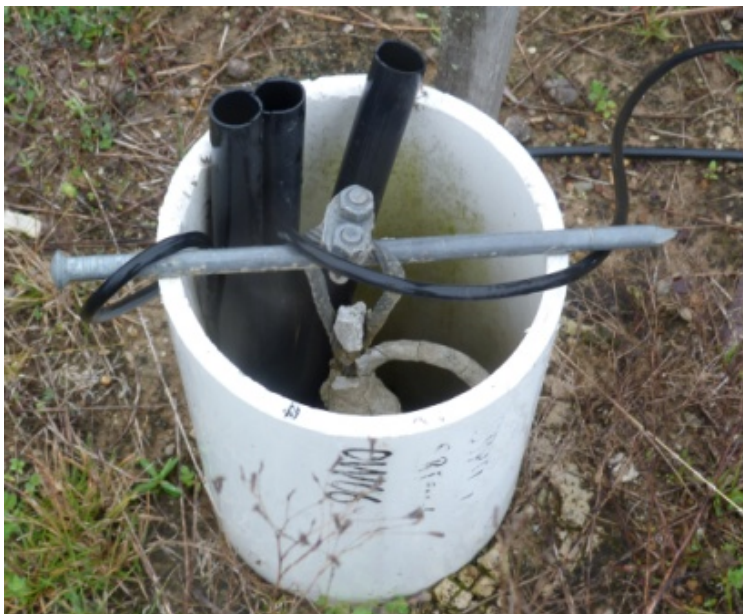
**Figure 29 - Photo looking at the top of typical piezometer hole at Blakefield South Mine.**

Note that the photo in figure 29 the piezometer hole (otherwise known as an environmental monitoring hole) at the surface, the piezometer is suspended in the borehole via a wire rope attached to a steel nail and insulated from earth via a polyethylene pipe. These piezometer holes extend all the way into the Blakefield seam in LW1 and as the longwall passes them, they are then cut out and the remainder of the piezometer is left in the goaf still attached to the surface piezometer infrastructure. Mr Gillespie's report identifies that the closest piezometer hole is some 400 metres from where the major ignition point is thought to be from the eye witness accounts. However, this does not preclude the possibility that at the time of the incident an explosive fringe may have extended across the back of the longwall in to the goaf to a point adjacent to where this borehole entered the mine.<sup>35</sup> Figure 30 shows the location of the piezometer holes with respect to LW1.
