Investigation report

Report into the death of Mark Daniel Galton at
Boggabri Coal Mine on 21 May 2014

Report prepared by the NSW Mine Safety
Investigation Unit

Published report date: August 2015

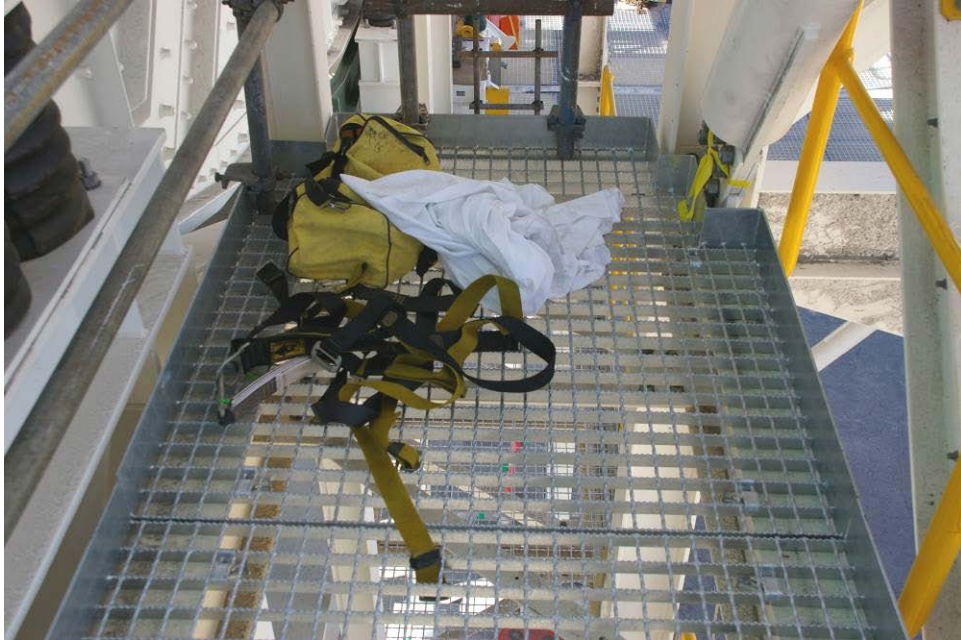
Witness accounts are not clear as to whether Mr Galton's yellow tool bag, which was fully loaded with tools and was found on the gantry walkway after the incident was in the platform at the time of the incident.

Figure 27: Mr Galton's yellow tool bag and a working at heights harness found on the walkway adjacent to the platform.

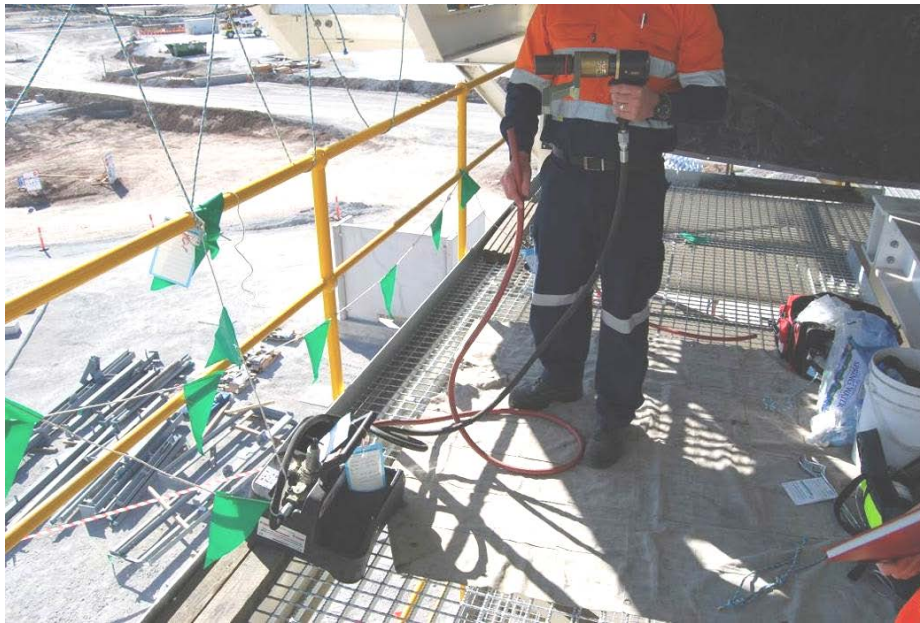
1. Mr Galton and his working at height equipment PPE
2. air receiver box
3. rattle gun (equipment referred to as a nut runner)
4. air hose (black colour) to rattle gun
5. air hose to ground level (red colour to compressor)
6. tools, rattle gun sockets and various size nuts and bolts

Figure 28: Photograph of a person holding the rattle gun and air hoses leading to and from the air receiver box all of which were in the platform with Mr Galton.

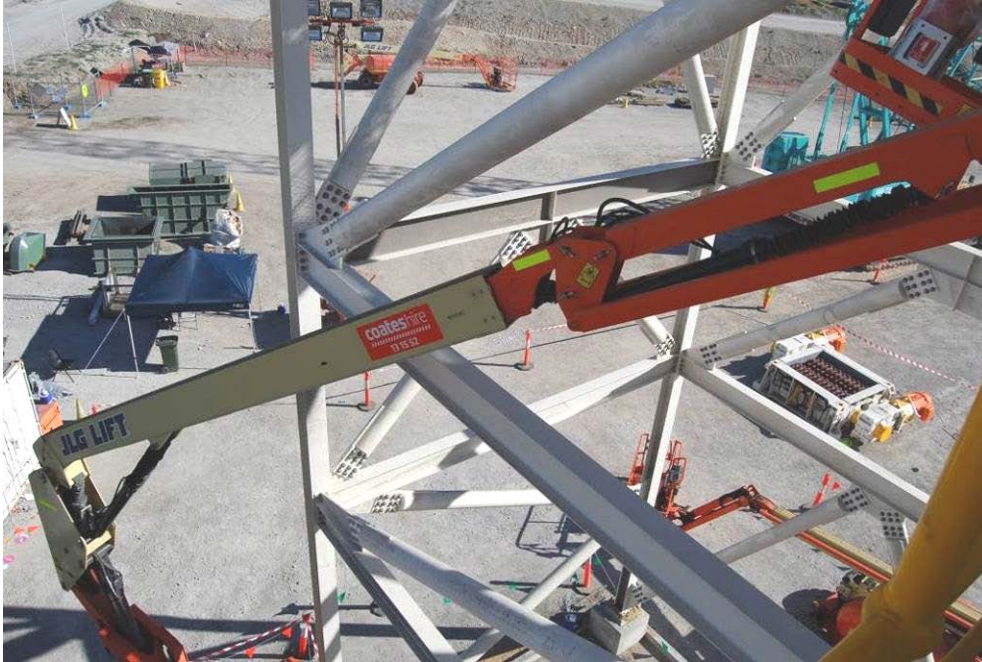
The platform was observed to be rotated to the right (in relation to the operator console position) and close to being parallel with the raised jib. The fly boom was raised but not extended. The base boom was raised.

Figure 34: View from the walkway of the position of the raised base boom, fly boom and jib in relation to the rotated platform.

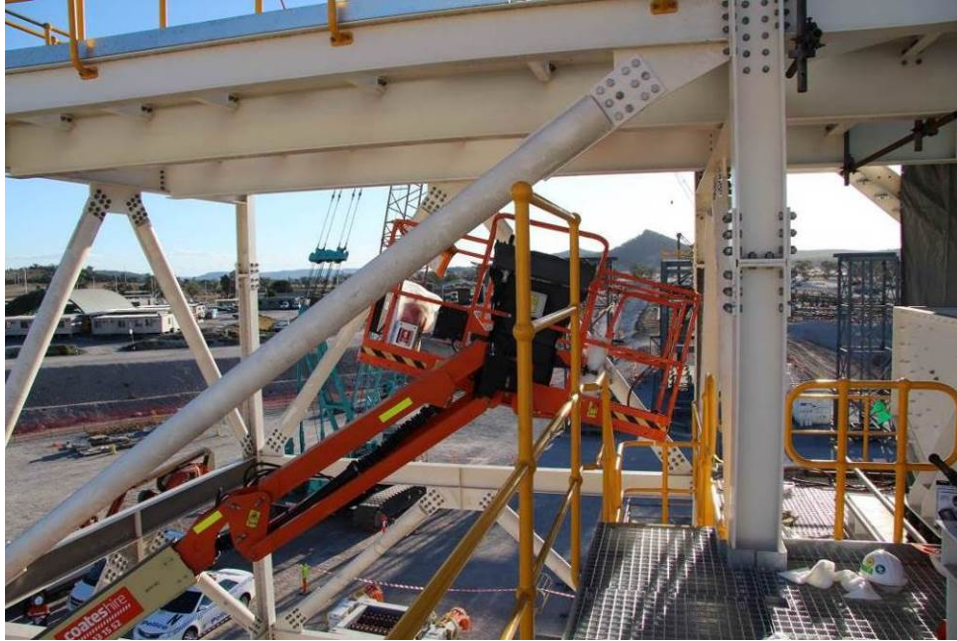
The position of the platform after the recovery of Mr Galton was observed to be rotated on the articulating jib rotator parallel with and to the left hand side of the turntable of the MEWP. The platform was across the top of two yellow painted handrails of steps on a walkway under the third floor level of ST202. The platform was lowered onto the top handrail of the steps during the recovery of Mr Galton.

Figure 36: Platform and articulating jib position in relation to the stairway handrail.

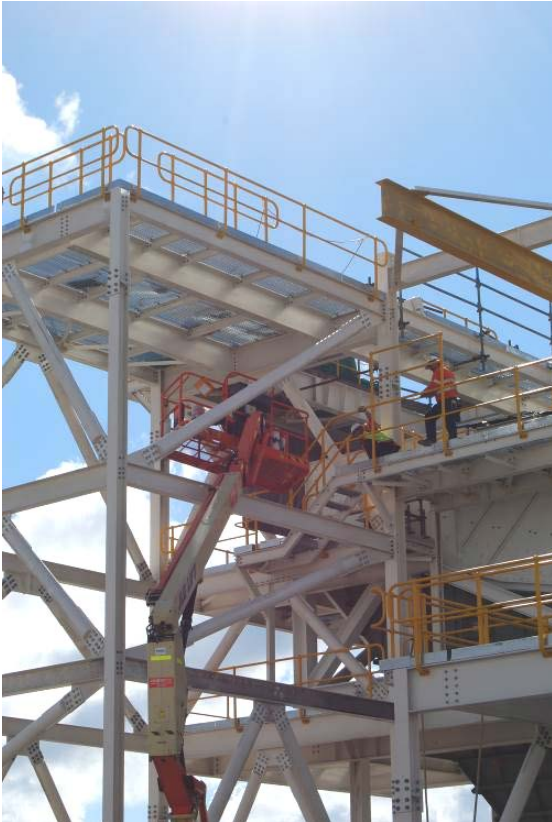
Observation during lowering of the platform after the incident identified that the platform initially required to be moved horizontally sideways to clear the top of the handrails and then lowered adjacent to the walkway handrail. The main boom moved closer to the steelwork.

Figure 39. View of the platform moving parallel with the steelwork and lowered adjacent to the walkway steps handrail. Photo taken during lowering of the platform on 23 May 2014. The spotter is on the second floor walkway. The articulating jib and main boom have moved closer to the steelwork of the structure.

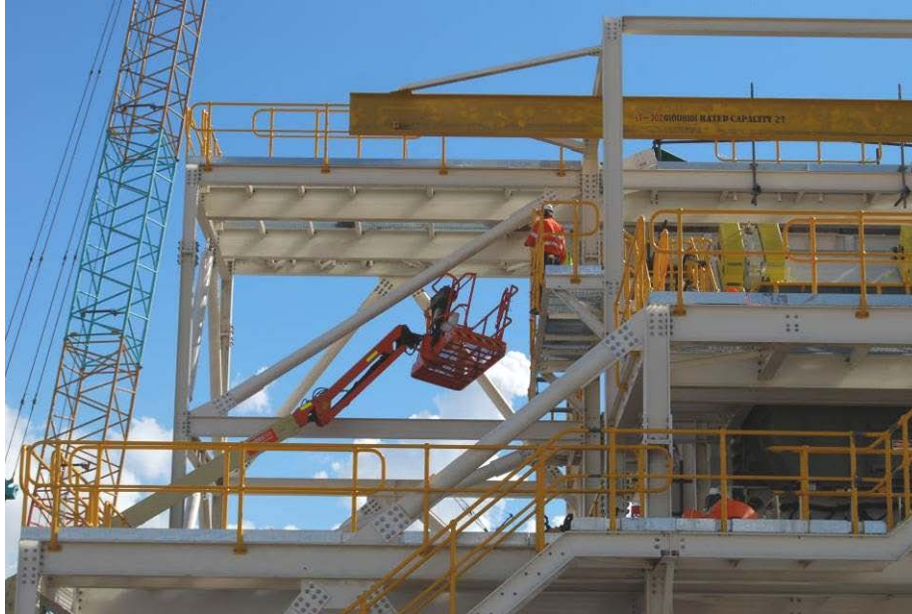
The platform was then rotated 90° to allow movement parallel to the walkway handrail and then moved horizontally through a space bounded by the second floor steelwork underneath the platform, the underside of the angled cross brace pipe work above the platform control console and the walkway handrail adjacent to the platform. The platform was also tilted downwards towards the handrail to pass underneath the angled cross brace.

Figure 40: View of the platform rotated adjacent to the walkway steps handrail and tilted underneath the angled cross brace pipe. Photo taken during lowering of the platform on 23 May 2014.

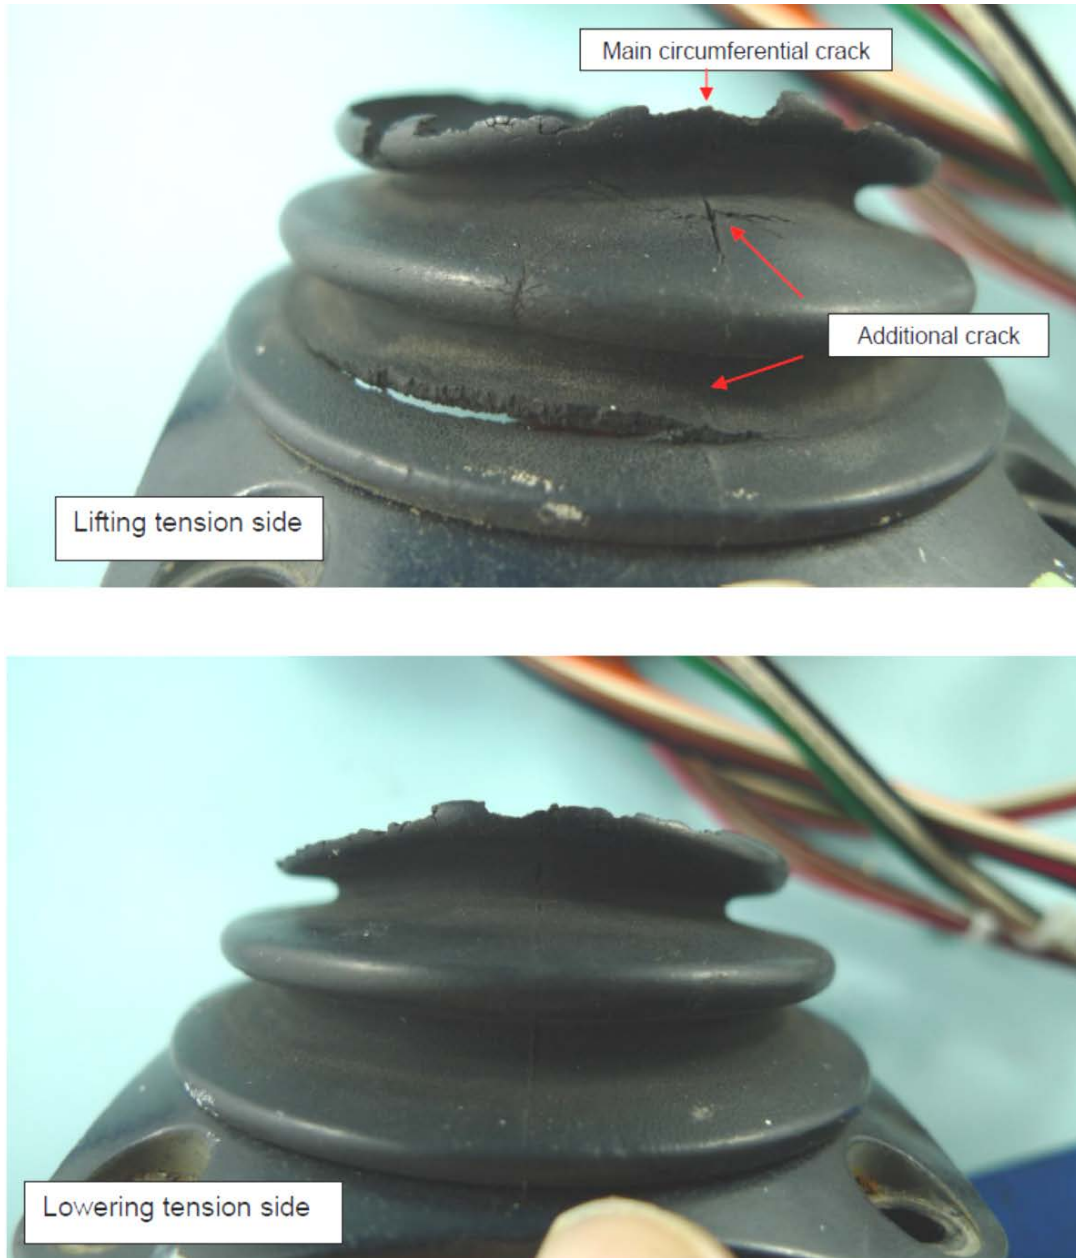
Figure 44: Extract of Bureau Veritas report – Figure 3.

'Visual examination of the joystick unit indicated the absence of mechanical-related failure which could have caused the possible malfunction of the unit. The primary damage was identified to be the rubber protective boot cracking. However the condition of the circuit board was also found to be less than optimal which had been introduced during the manufacturing process. Further investigation would be required to verify the functionality of the circuit board.'

Figure 3 Views showing the multiple crack indications below the major circumferential crack on the lifting tension side, while the lowering tension side was free of any visible damage.

- Operators and maintainers of MEWPs should ensure close inspection of the rubber protective covers of platform controls to identify deterioration such as cracking and splitting, which can allow dust and water ingress and cause corrosion on electrical control circuit boards.
