Investigation report

Cause and circumstances of fatal injury to
Peter Thomas Jones at Chain Valley Colliery
on 3 June 2011

Extract of report prepared by the
NSW Mine Safety Investigation Unit

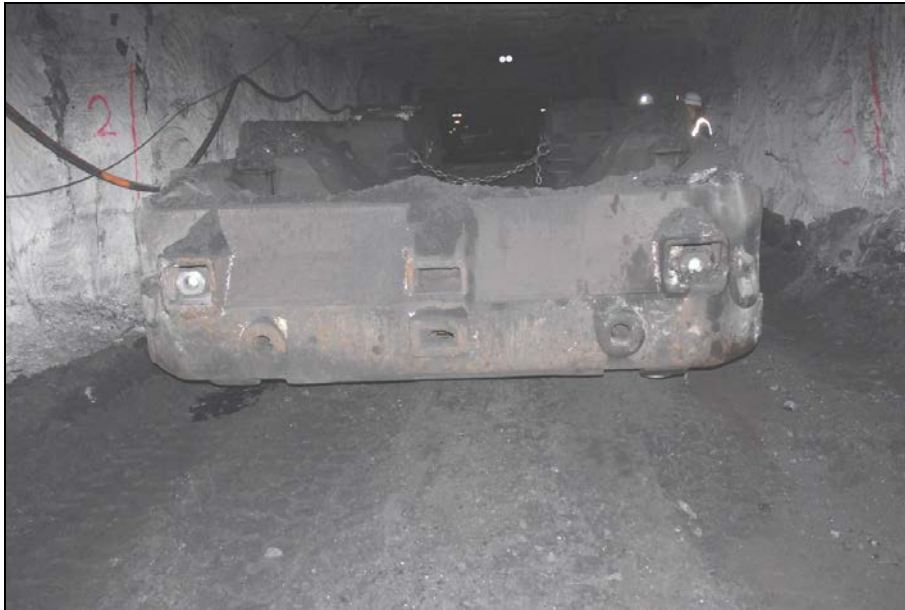
Photograph 20 Looking outbye in B Heading of the right hand shuttle car.

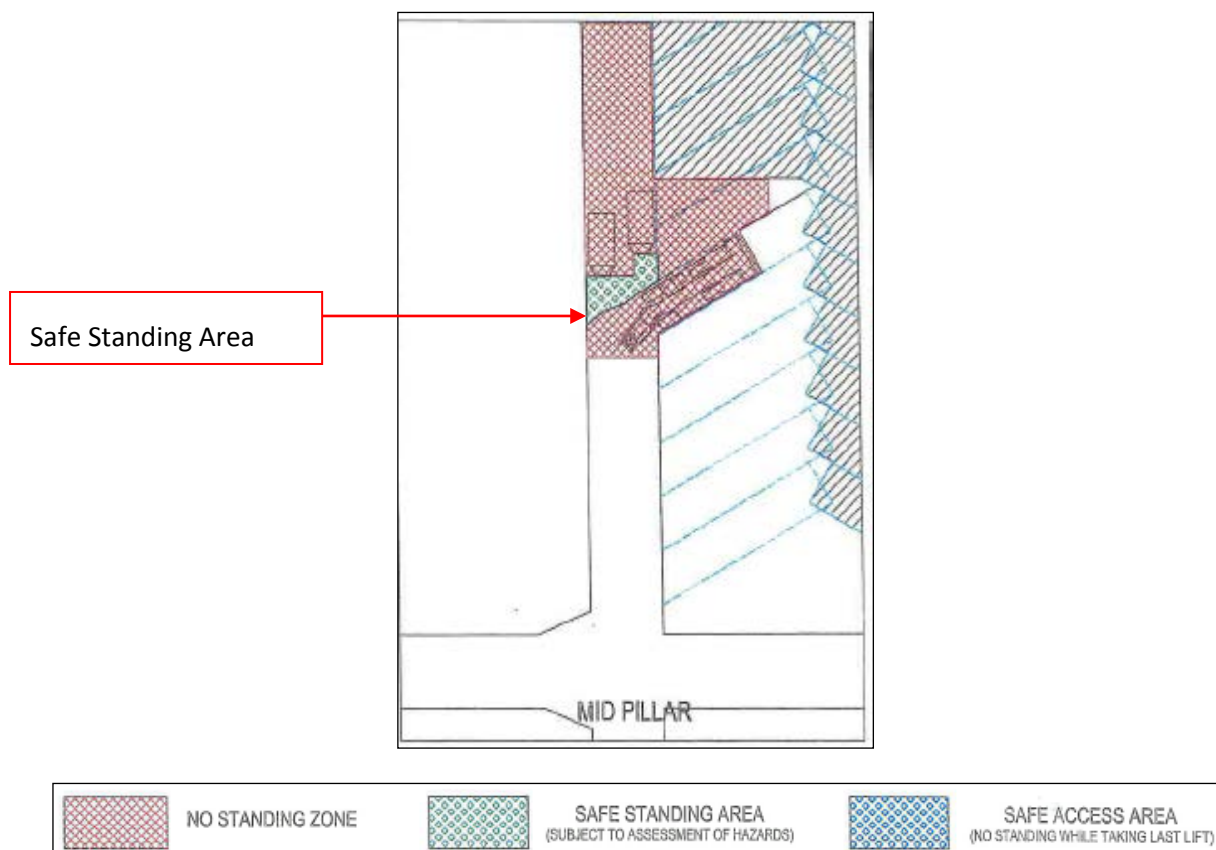
Figure 10 Extract of Fassifern Seam West Panels Safe Standing Areas Single Sided Lifting 11 June 2010

The pillar extraction method in West 6 was different to that in the two safe standing area plans: Chain Valley Colliery was using double sided pocketing extraction with two breaker line supports.

The two documents were shown to mine management by investigators. It was identified that the plans were not specific to the system of work at the time of the incident. However, in review of the available plans, it was indicated that Mr Jones was standing in a “safe standing area” as highlighted in green. That is, it was safe to stand in the position *if all conditions of the managers support rules were sufficiently in place.*
