THE INVESTIGATION OF A COAL MINE EXPLOSION	5. 1
	FORENSIC SCIENCE EXAMINATION OF RECORDS AT MOURA NO.4 MINE EXPLOSION, 1986	5. 1
5.1	Investigation of a Coal Mine Explosion	5. 1
5.2	Methods of Examination at the Mine	5. 1
5.3	Use of Forensic Pathology in Coal Mine Explosion Investigation	5. 2
5.4	Forensic Science Examination of Records at Moura No.4 Mine Explosion 1986	5. 4
5.4.1	Forensic Science	5. 4
5.4.2	Forensic Pathology	5. 5
5.4.3	Recovery of the Victims at Moura	5. 6
5.4.4	Post Mortem Reports	5. 7
5.5	Examination of Records	5. 8
5.5.1	Classification of the Incident	5. 8
5.5.2	Approach to the Scene: Immediate Actions	5. 9
5.5.3	General Characteristics of the Explosion	5.10
5.5.4	Observed Personnel Effects	5.11
5.5.5	Condition of Deceased Miners after Explosion	5.14
5.5.6	Observed Material Effects	5.14
5.6	Discussion	5.16
5.7	Summary	5.16

MINE EXPLOSION ANALYSIS.	6. 1
6.1	Investigation Techniques	6. 1
6.2	Australian and Overseas Forensic Research	6. 2
6.2.1	Estimating Overpressures from Damage to Structures	6. 3
6.2.2	Displacement of Objects	6. 3
6.2.3	Heat Damage	6. 4
6.3	Modelling of Explosions	6. 5
6.3.1	Physical Models	6. 5
6.3.2	Mathematical Models	6. 6
6.4	Reanalysis of

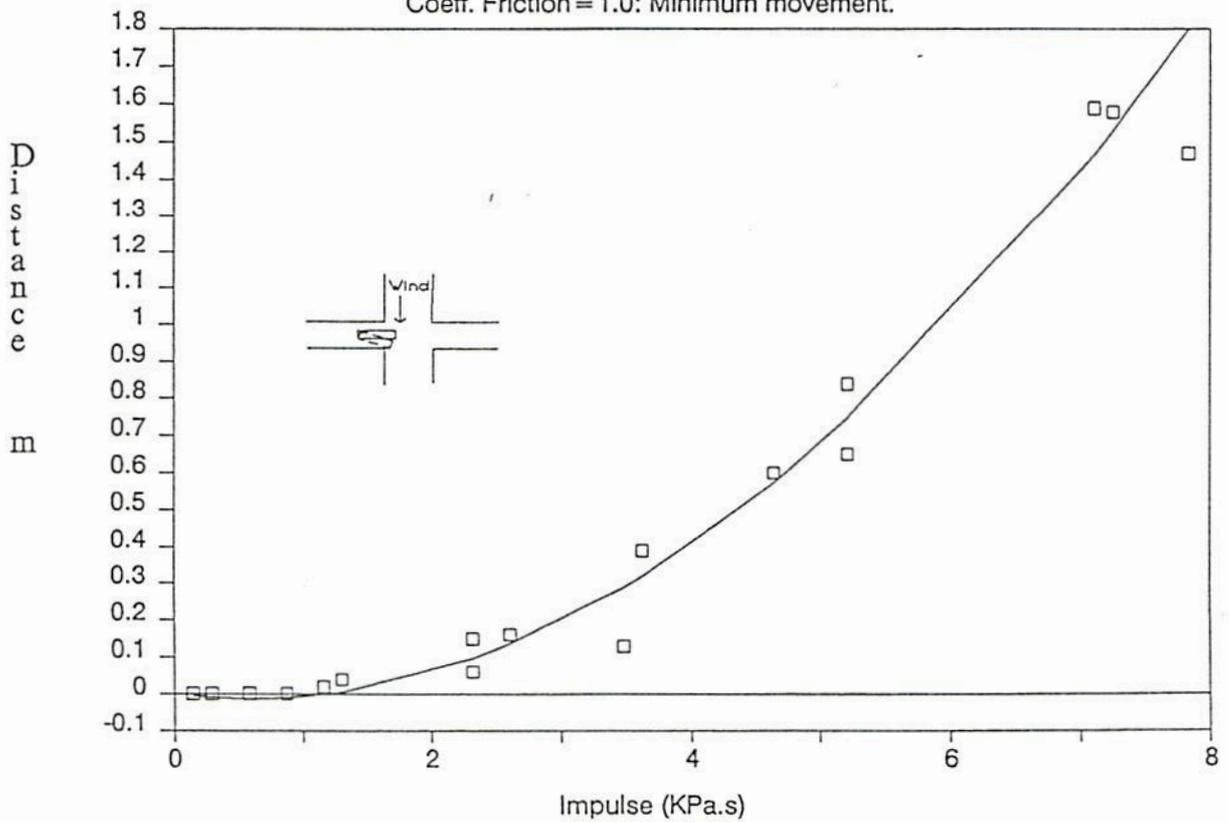
Figure 6.5 End Displacement of Shuttle Car 31

These values are shown on Figure 6.5 and correspond to movement of s/c No.31 of between 0.6m and 0.9m. It should be emphasised that this range is a minimum. A coefficient of friction of 0.3 would yield a range of movement of between 2.0m and 3.5m.

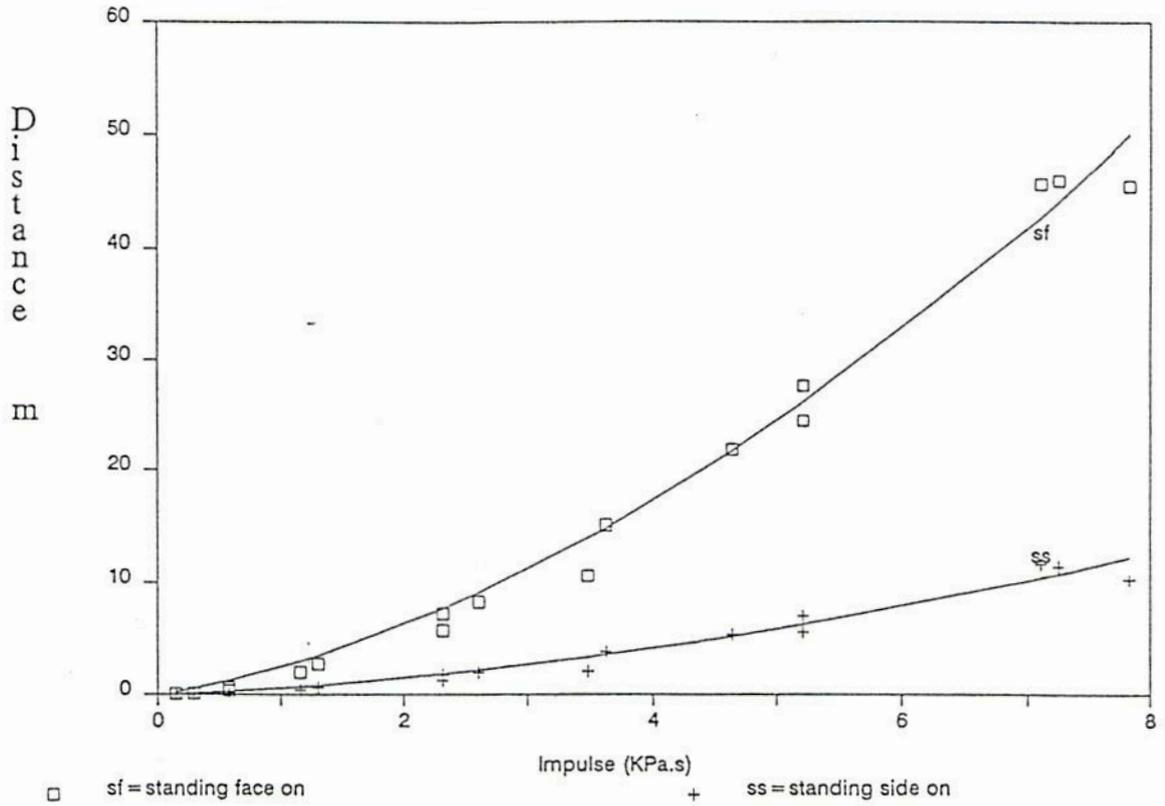
Figure 6.6 Body displacement.

The body displacement for the four wind durations considered previously are given in Table 6.6. The distance travelled is plotted as a function of Impulse in Figure 6.6. The three bodies found near 26 c/t and No.4 Supply Road would have been subjected to an impulse of between 4.3kPa.s and 5.2kPa.s. This corresponds to a displacement of between 5m and 26m. The impulse in the region of 26 c/t and No.3 Belt Road as indicated in Section 6.2.2 is between 4.6kPa.s and

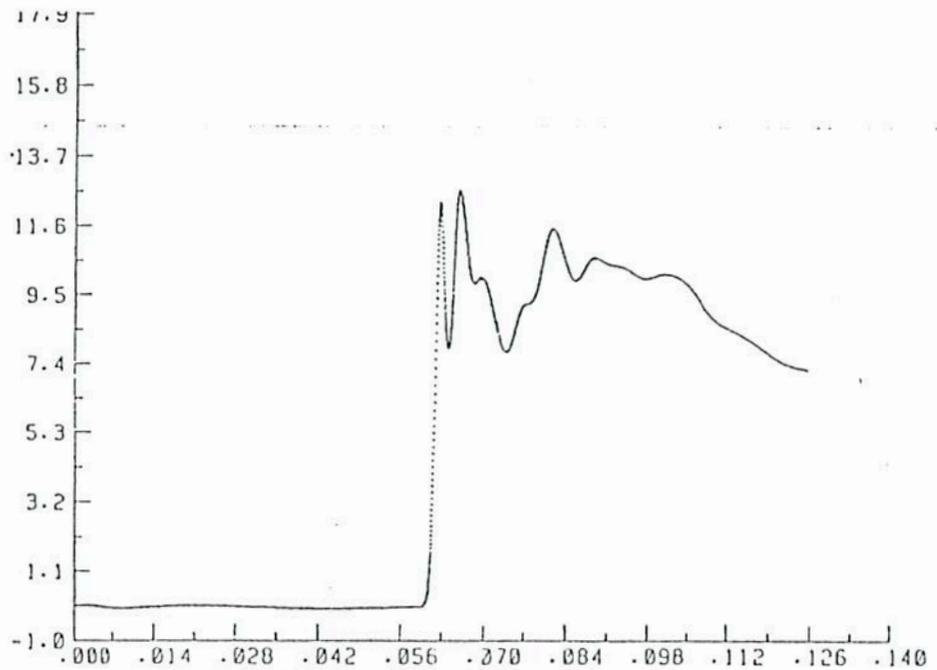
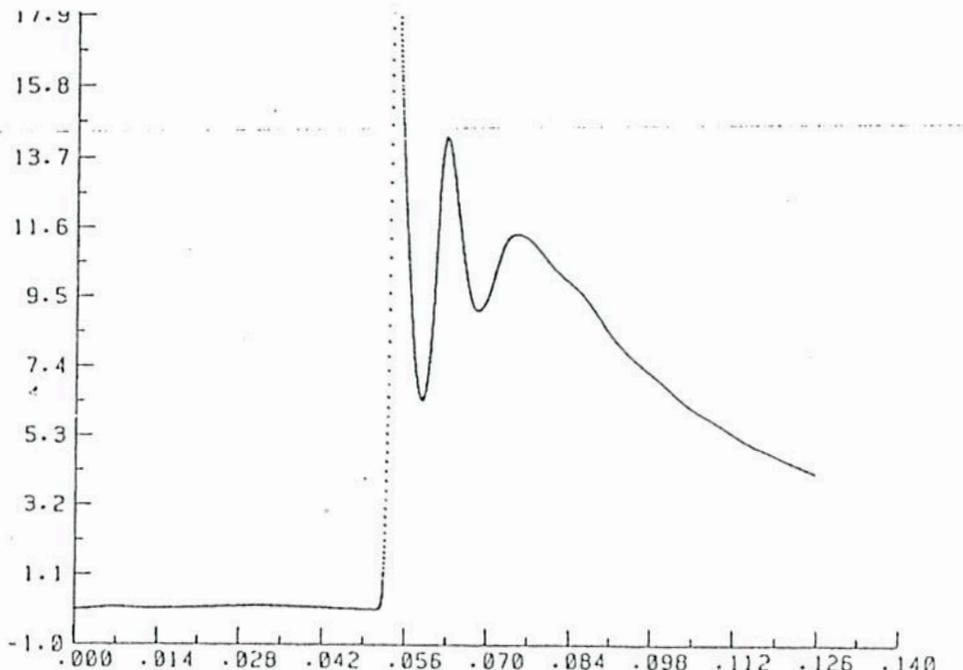
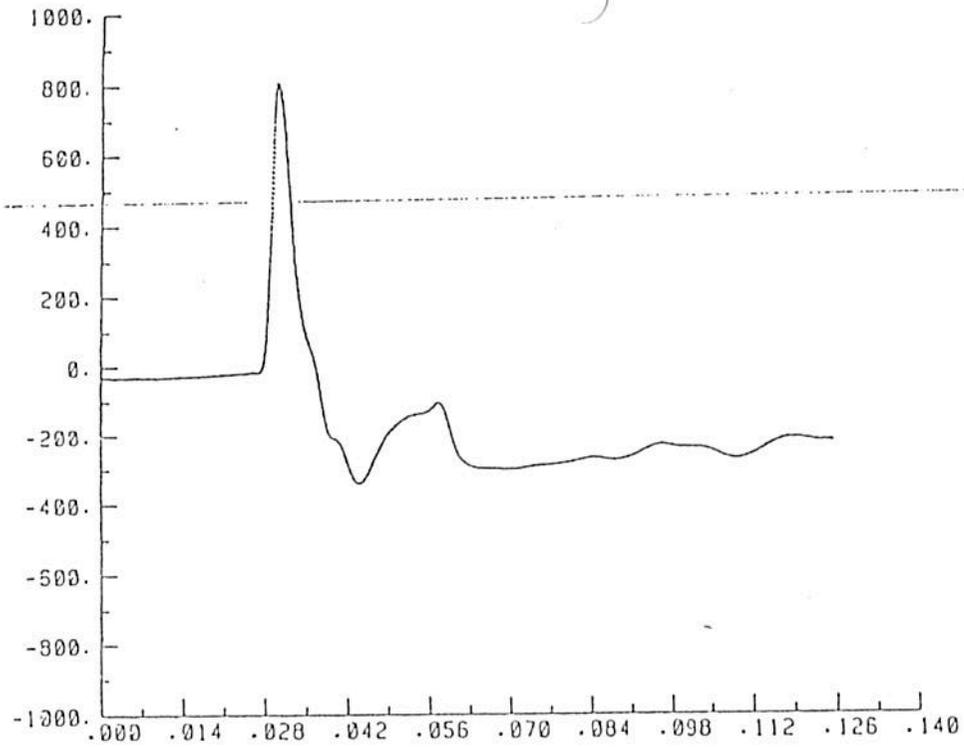
FIGURE 6.12 PRESSURE: IGNITION AT 27C/T AND NO. 4 SUPPLY ROAD

Figures 6.12 to 6.14 show the pressure, velocity parallel to No.4(u) and velocity perpendicular to No.4(v) for ignition at the intersection of 27 c/t and No.4 Supply Road. A positive u velocity corresponds to movement along No.4 Supply Road away from the goaf. A positive v velocity corresponds to movement from No.3 Belt Road towards No.4 Supply Road. In this simulation the stopping at 26 c/t is present and all the vehicles and conveyor are in the positions shown in Figure 6.12.

The time histories of 4 points are shown in Figures 6.12 to 6.14 corresponding to points 10, 7, 2 and 3.

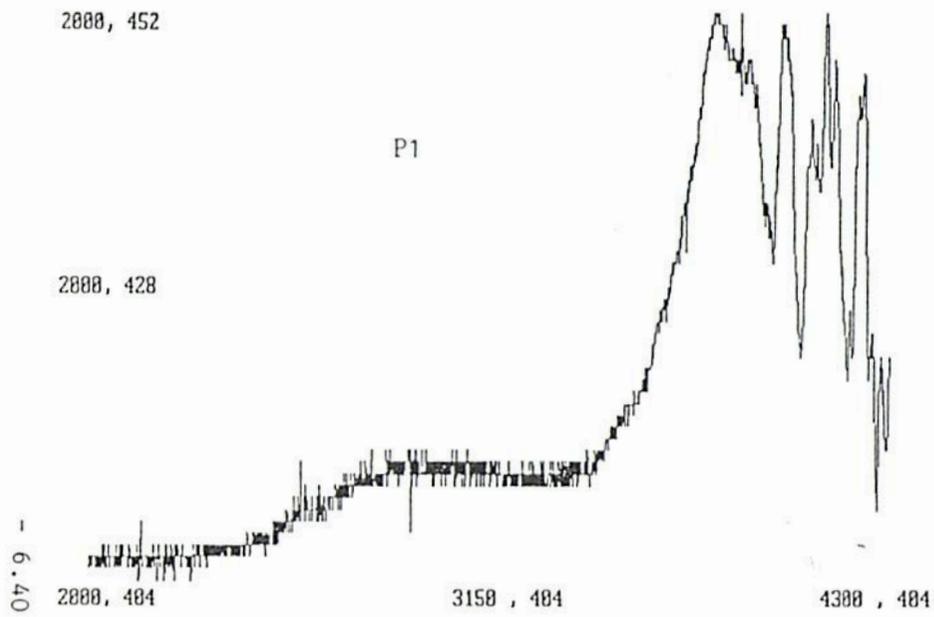
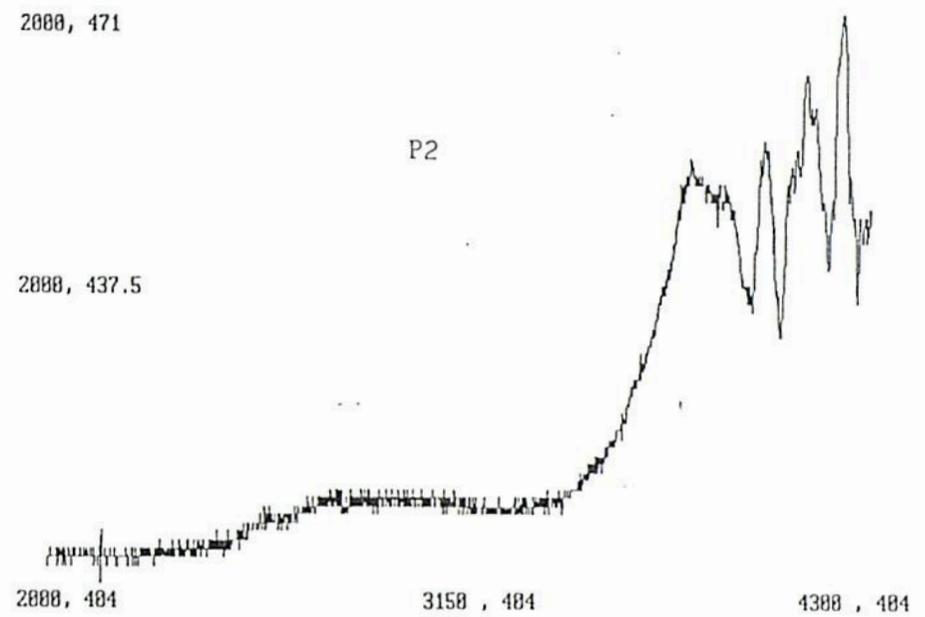
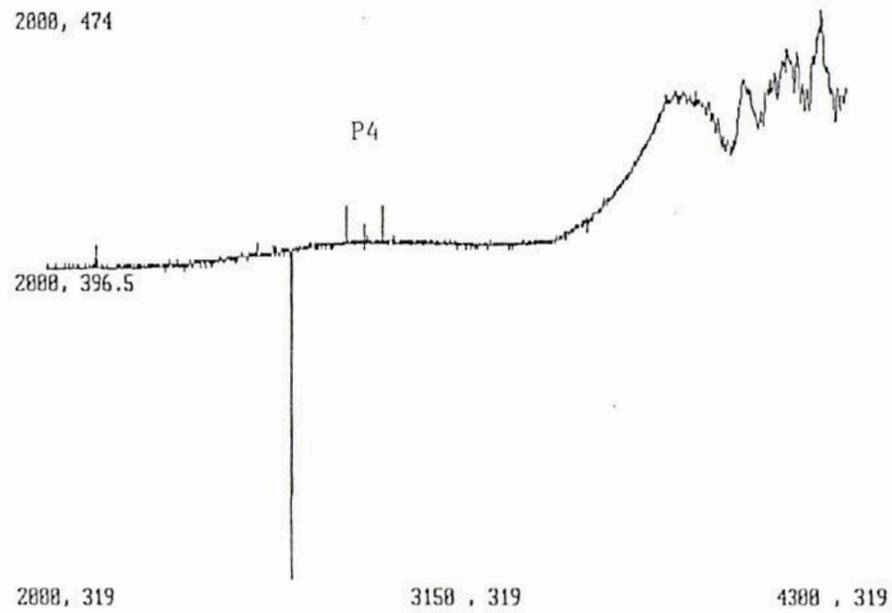
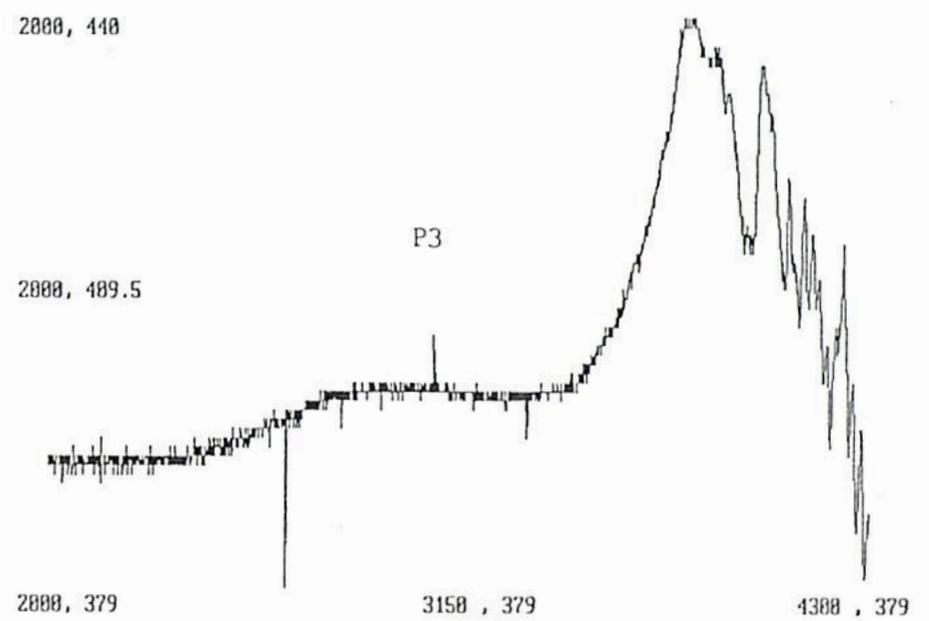
FIGURE 6.15 PRESSURE FROM SCALE MODEL EXPERIMENTS: IGNITION AT 27C/T AND NO. 4 SUPPLY ROAD

This complexity is also found in the physical model. Figure 6.15 shows the pressure at this intersection for the same ignition conditions although this corresponded to an 8.3% methane air mixture as opposed to a 9.4% methane air mixture. The ignition source is also much weaker than that simulated in the computer experiment, hence the lower pressures and longer timescales for the physical model experiments. At point 3, the first peak is 50% higher than that at point 7 and corresponds to a very intense flow along 26 c/t from No.4 Supply Road(v). This strong flow also set up an outward flow (+u) along No.3 Belt Road due to the obstruction of the two shuttle cars. The second peak is due to a reflection from s/c No.30 in 26 c/t.

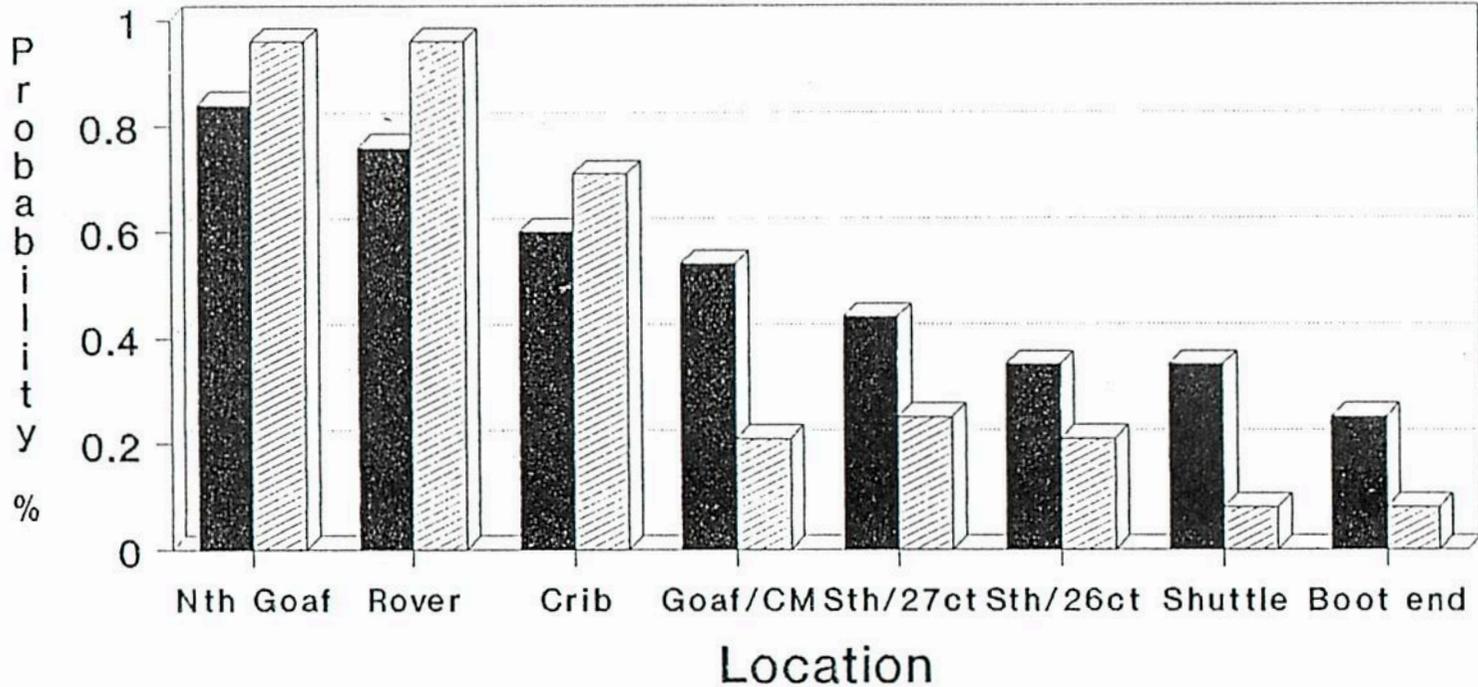
Figure 7.1 Ignition Sources Probability for various locations

Figure 7.1 plots a percentage probability of ignition for several hypothesised ignition zones. The scaling has been based on +2 for a positive factor, +1 for a positive factor that needs further testing, 0 for a neutral or unknown factor, -1 for a negative factor that needs further testing and -2 for a negative factor. This process results in a value for each hypothesis between +34 and -34. This range has been converted to a percentage probability.

Applying this additional weighting, the critical data set is reduced to six factors, Nos.3, 4, 5, 7, 8 and 13 given in Table 7.1. This reduced set is also plotted in Figure 7.1.

Note: Rover relates to area immediately in front of the vehicle.
