OUTBURSTS AT COLLINSVILLE — A CASE STUDY

ABSTRACT

The Aus. I.M.M. Southern Queensland Branch, The Occurrence, Prediction and Control of Outbursts in Coal Mines Symposium September, 1980

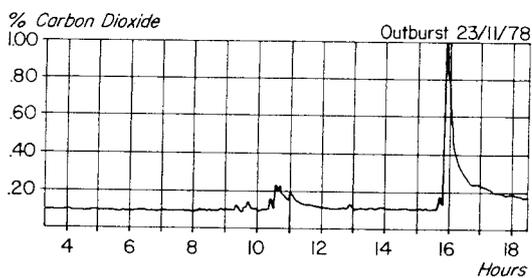
Fig. 15 — Gas chart from No. 1 Fan 23.11.78

Ventilation at the face was 13.8m³/sec. Recording from the M.S.A. gas monitor showed CO₂ in excess of 1% for a period of 18 minutes at a sample point in the panel return. See the gas chart figure 15. 260m³ of gas was emitted in twenty-five minutes and 940m³ over six hours.

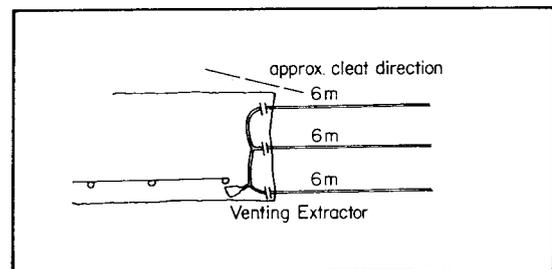
Fig. 22 — Method of gas drainage

Three 43mm holes were drilled across the face to a depth of 6 metres at mid-working height and approximately 2 metres spacing. Each hole was sealed using Stauff dilatable seals and coupled via a manifold to the Stauff Venturi duster. See figure 22.
