QUEENSLAND GOVERNMENT
DEPARTMENT OF NATURAL RESOURCES, MINES AND ENERGY
RESOURCES SAFETY AND HEALTH

INVESTIGATION REPORT

FATAL ACCIDENT

**FAIRFIELD QUARRY
CLERMONT, QLD.**

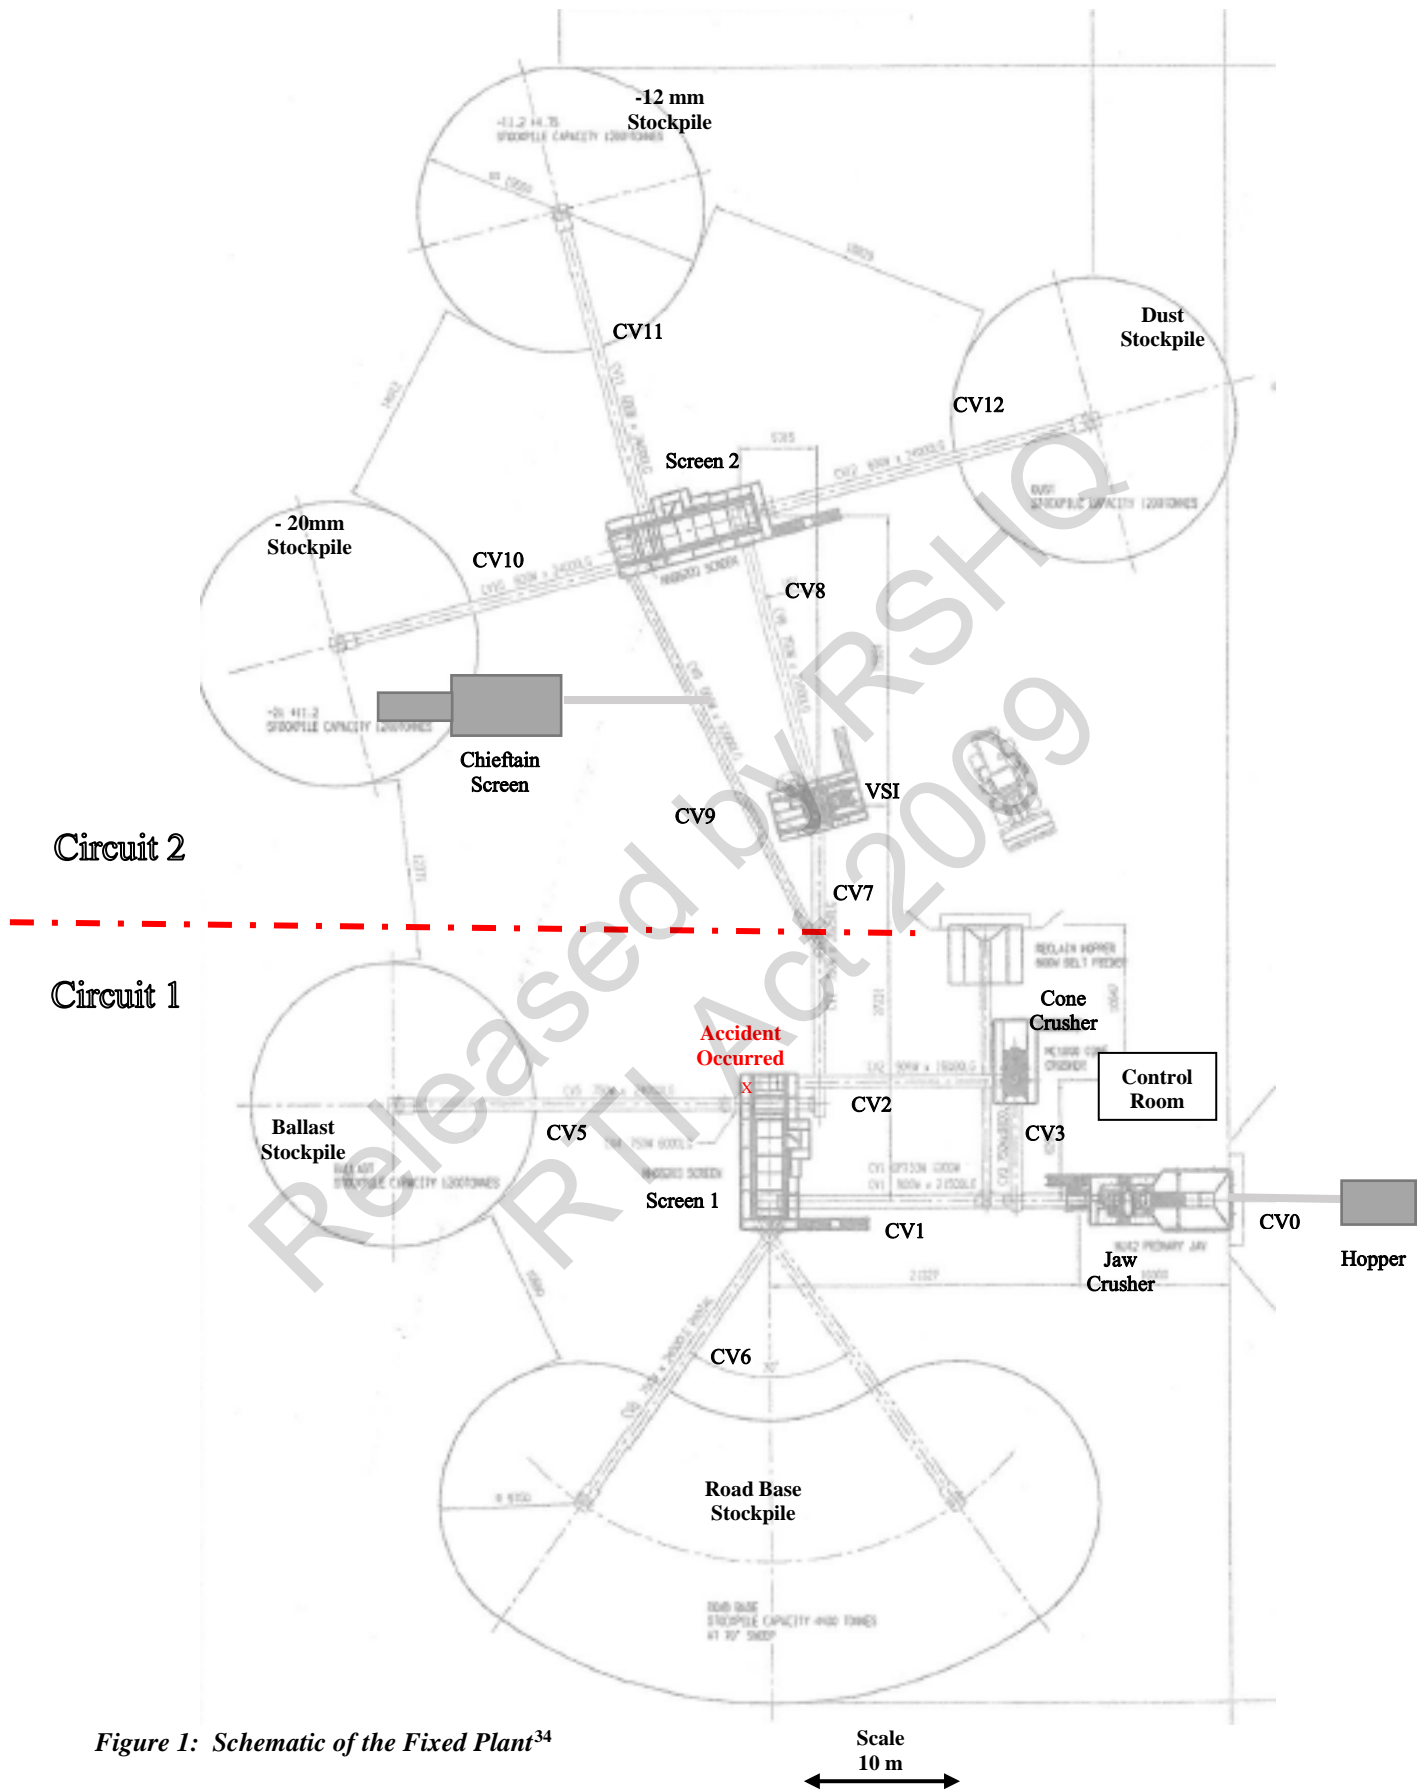
Figure 1: Schematic of the Fixed Plant³⁴

The circuit where the accident occurred was *Circuit 1* (Refer to *Figure 1 Schematic of the Fixed Plant*). The flow of product through this circuit was:

Prior to morning break, Mr MILNE was operating a Caterpillar 966 Loader feeding rock through the Chieftain 1400 Mobile Screen onto *Circuit 2* (Refer to *Figure 1 Schematic of the Fixed Plant*).³⁰

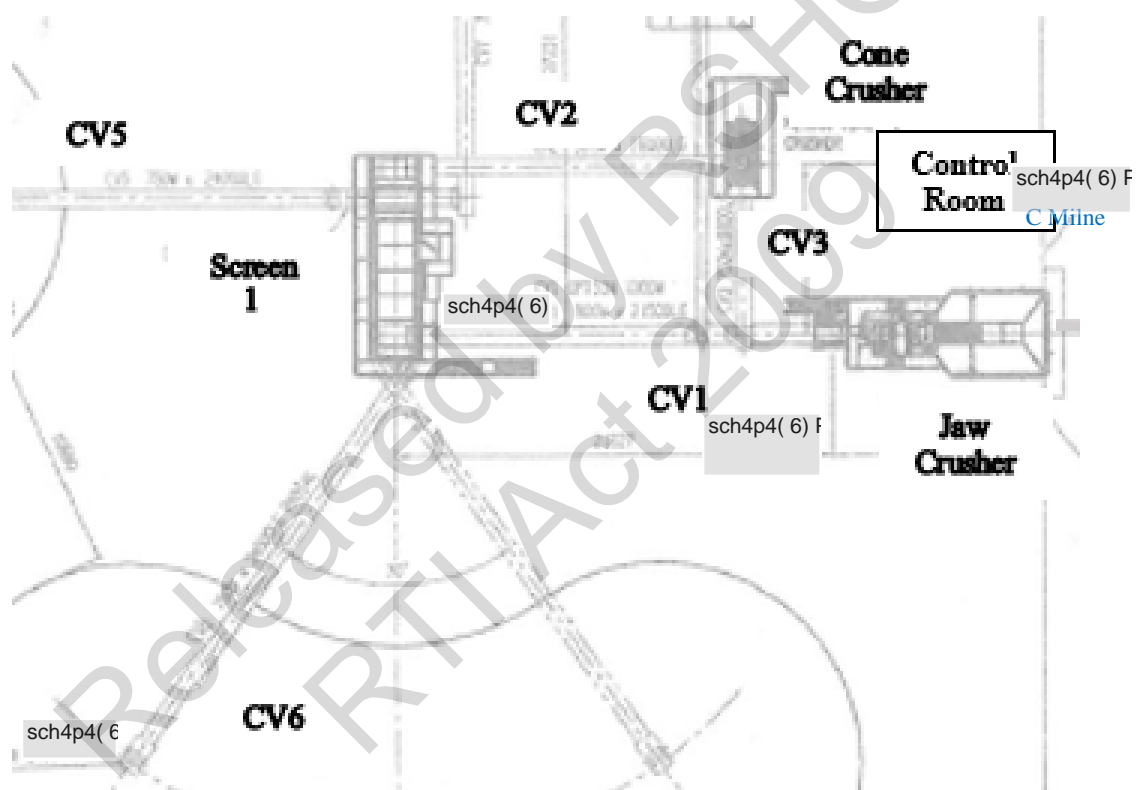
Figure 2: Schematic depicting location of individuals at start-up of Fixed Plant

On start-up, the location of personnel (Refer to *Figure 2: Schematic depicting location of individuals at start-up of Fixed Plant*) was:

- [sch4p4(6) Personal info] was in a light vehicle near CV1;
- [sch4p4(6) Personal info] was near [sch4p4(6) Personal info];³⁶
- [sch4p4(6) Personal info] as in a loader with the bucket under CV6 discharge to minimise product contamination;³⁷
- Mr MILNE and [sch4p4(6) Personal info] were in the Control Room;³⁸ and
- [sch4p4(6) Personal info] was starting the Terex plant from the ground level.
