# **Investigation report**

**Report into a fatality at Goonyella Riverside Mine on 5 August  
2017**

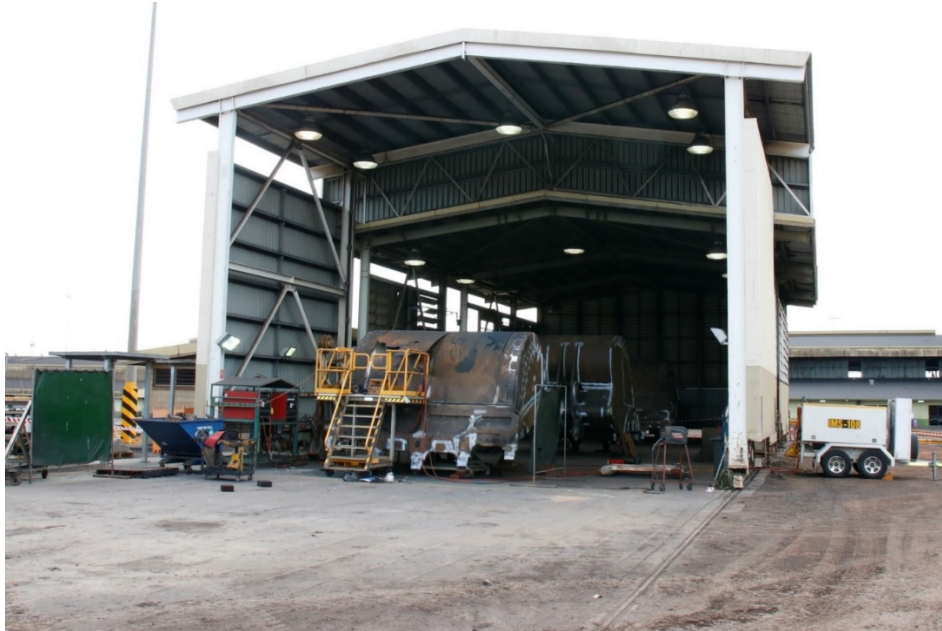
***Figure 6 - Photo of the maintenance bucket shop and bucket #1 post accident***

Mr Springer was struck in the upper forehead area by the steel wear plate. Evidence suggests that Mr Springer had just completed air carbon arc gouging the wear plate, and had lifted his welding face shield and hung the air carbon arc gouger handpiece over the adjacent handrail on the work platform that he was working upon. Given the position of the injury on his forehead it would appear that Mr

Springer was looking back at the steel wear plate when it suddenly released and sprang up 600 to 650 mm.

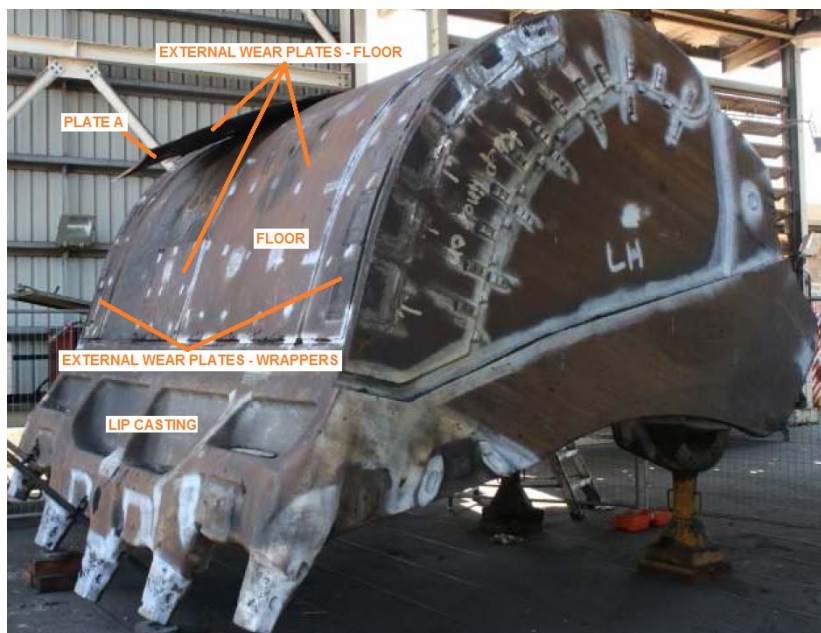
**Figure 10 - Excavator Bucket**

The bucket has three layers i.e. a structural steel shell with inner and outerwear liners. The external outer floor wear liner (plates) can be seen in **Figure 10**. Plate A is the one involved in the incident.

According to the material certificates provided by ESCO, the external wear plate was manufactured by Nippon Steel in Japan to NSSMC Standard 'Abrex 400'. The chemical and mechanical analysis performed by UQMP proved that Plate A conformed to this standard. It was of good quality and suitable for the application. Before assembly, Plate A was bent to fit the profile of the bucket floor.

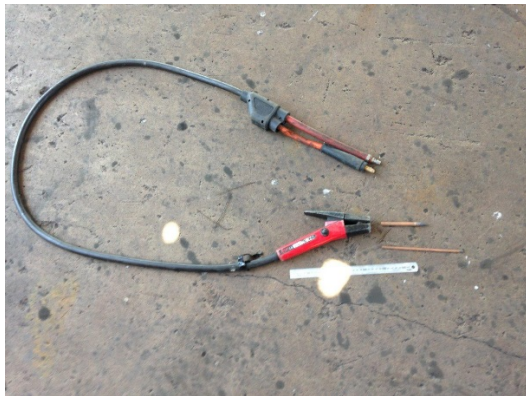
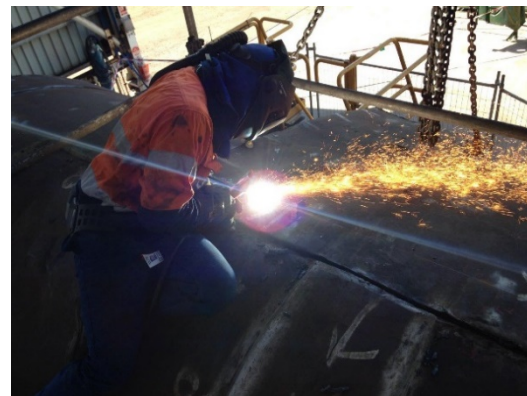
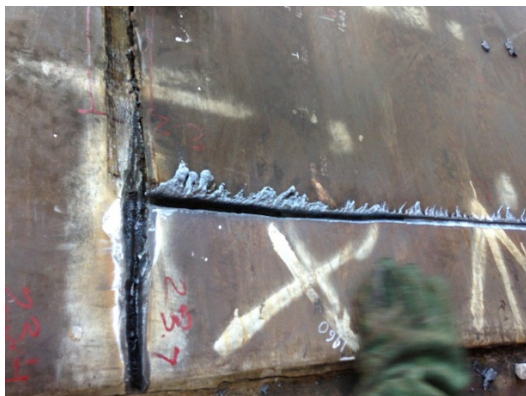
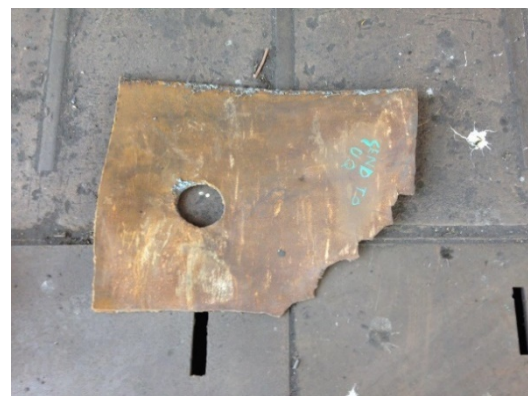
**Figure 13 - Gouging Plate A for this investigation [(a) Gouging rods, holder, air- and power supply (Scale: Steel ruler is 300mm long); (b) While gouging; (c) After gouging (d) Smaller**

Before a new outer floor liner could be installed, the existing liner (Including Plate A) had to be removed. It was detached by air carbon arc gouging and removing the welds that were holding it to the basket structure (see **Figure 11**). It was then cut into smaller pieces that could be man-handled.
