# Gleision Mine Incident

15 September 2011

A factual report by the Health and Safety Executive

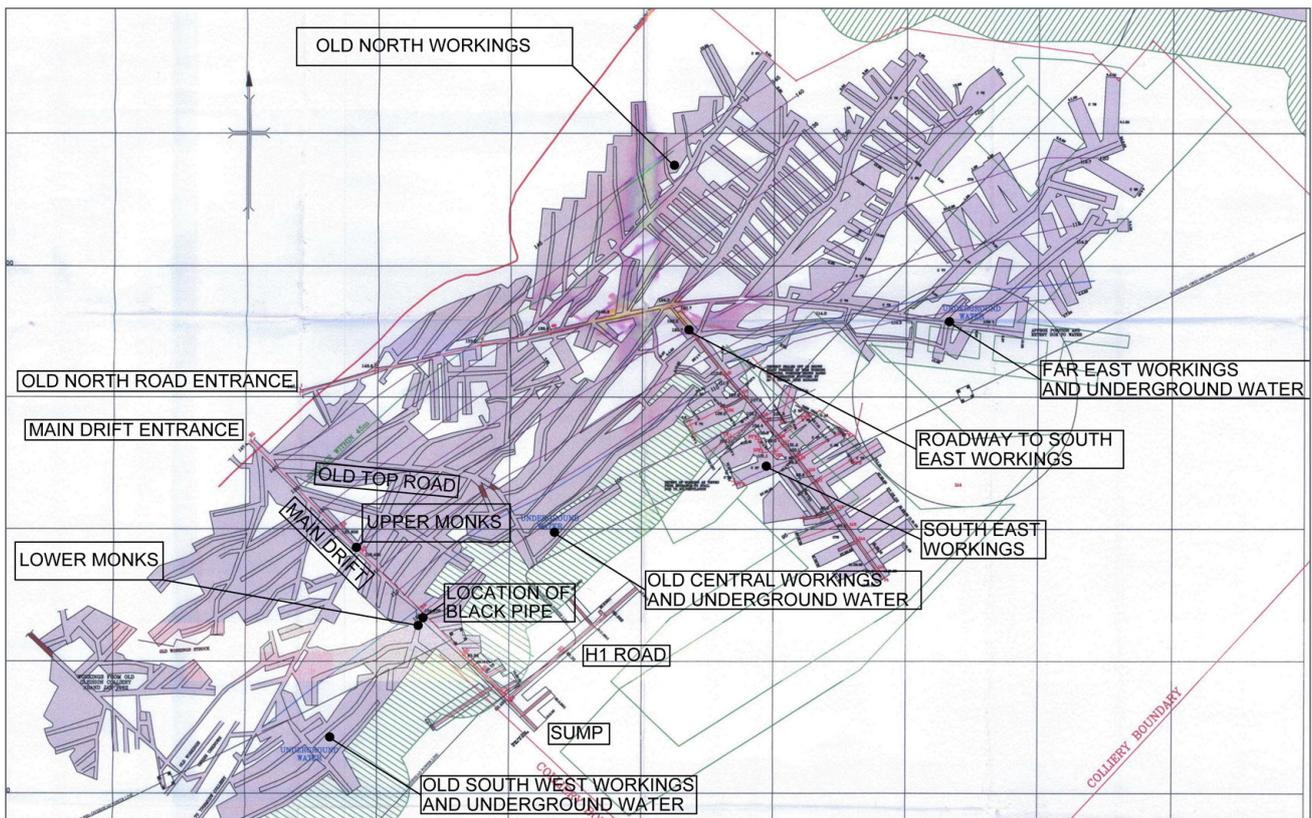
Figure 1 Mine plan

17 The green hatched areas to the south and east of both the Old South-West Workings and the Old Central Workings seemed to represent the 'cautionary zone' against potentially hazardous disused mine workings.

29 Some of the water overflowed naturally into the Old Gleision workings to the south-west at a point in the Main Drift known as the Lower Monks (see Figure 1). The remainder flowed down to the sump at the bottom of the Main Drift, from where it was pumped up to the Lower Monks and into the same disused mine workings. The water was then believed to flow through old Ynysmudw Colliery workings and then a series of interconnected old mine workings between the Swansea Valley and the Vale of Neath, eventually emerging at an outflow near Neath Abbey.

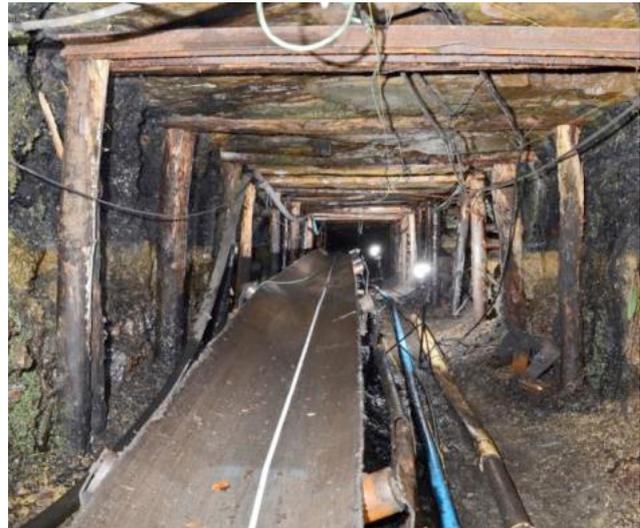
20 Both the 1.7 m high Main Drift and the Old North Road tunnels follow the coal seam into the hillside. The Main Drift slopes down at a gradient of about 1 in 5 for about 300 m in a south-easterly direction. Figure 2 shows the view looking down the Main Drift, with a belt conveyor on the left hand side.

**Figure 2** View looking down the Main Drift – the main way into the mine

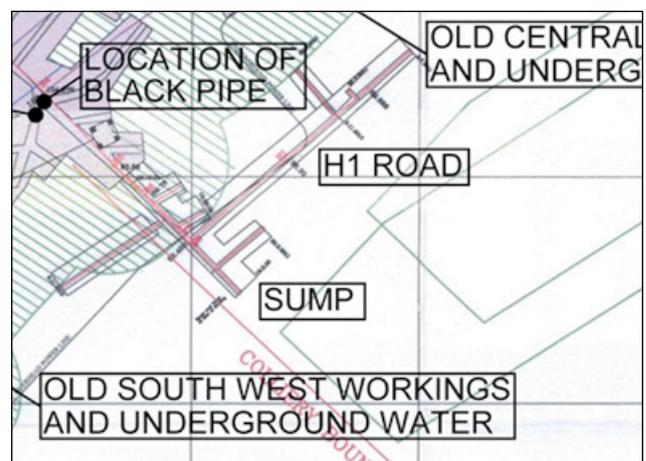
**Figure 4** Plan extract

22 The most recent coal workings shown on the mine plan were to the left-hand side of the H1 roadway – the area is shown more closely in the plan extract shown in Figure 4. The inrush stall is not shown as the work to drive it had not started when the 3 July survey was undertaken and the mine plan was updated.

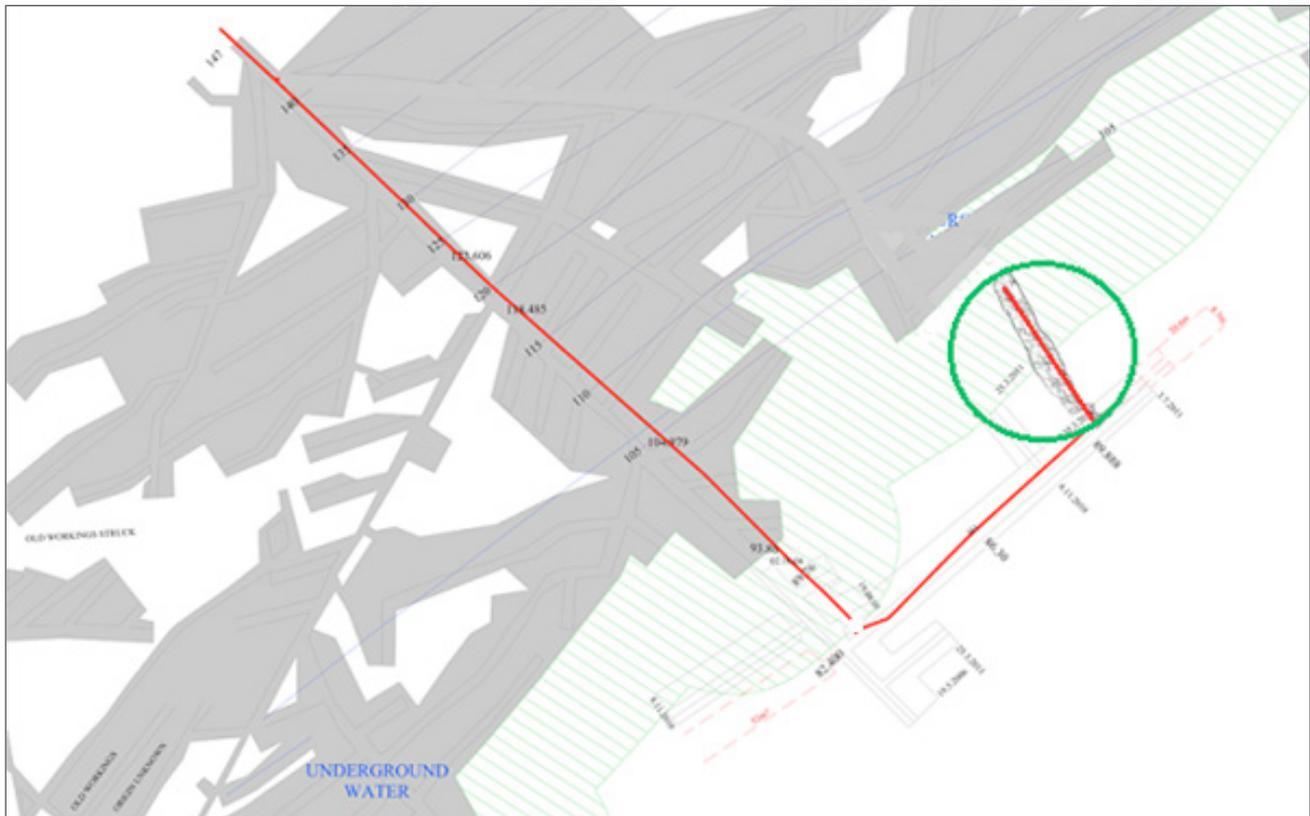
**Figure 5** The route the men took from the surface to the inrush stall (shown in the green circle)

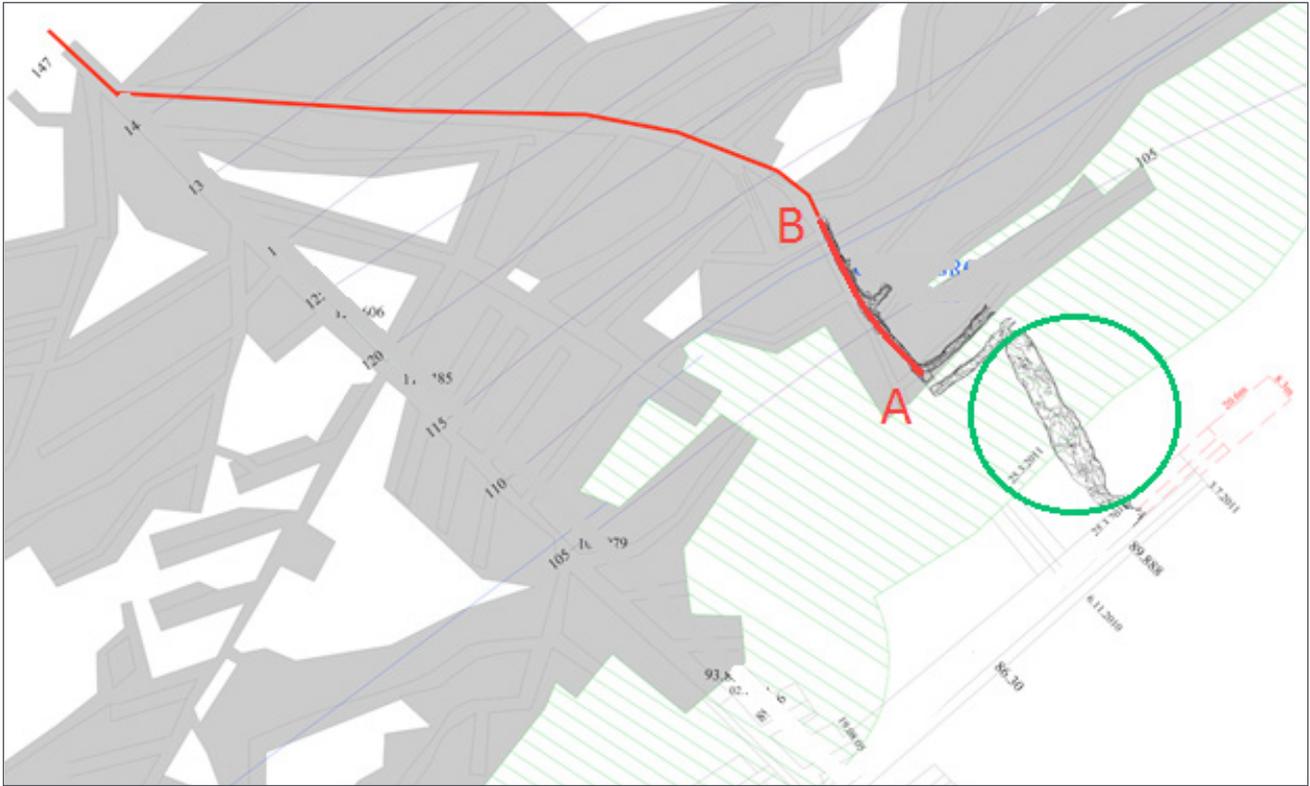
**Figure 6** Malcolm Fyfield's approximate escape route to the surface – his route from the inrush stall to point A is uncertain. Point B was where the first rescue team reached and encountered low oxygen levels. Point A was where the rescue team reached wearing breathing apparatus

44 At 11.05 am, MRSL reported to HSE that one man had escaped. This proved to be the mine manager, Malcolm Fyfield, who had escaped by travelling through an old part of the mine (see Figure 6). MRSL also confirmed that David Wyatt and Nigel Evans were safe on the surface, but that four miners were still missing.

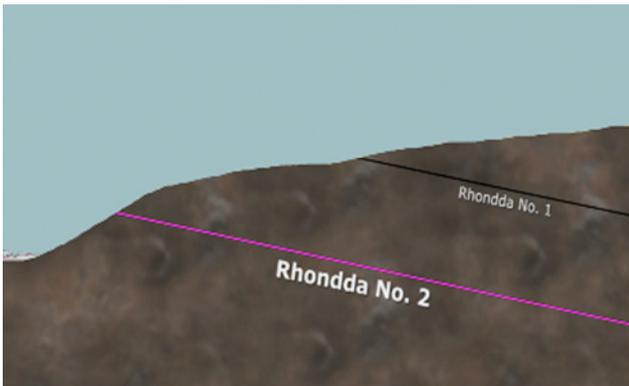
76 The part of the Pennant Sandstone Formation around the Rhondda No 2 workings is not known for having naturally occurring spaces, where water can accumulate. Also, there were no disused shafts within, or near, the Gleision workings, and no old mine workings above the Rhondda No 2 seam where water could accumulate. The maximum slope of the rock layers, or strata, in this area is around 1 in 5. This means that the rock drops, in a roughly south-easterly direction, by 1 foot for every 5 feet it travels into the hillside. Looking at the mine plan reproduced earlier in this report, the workings slope down from top to bottom (north to south) and from right to left (east to west). Figure 8 illustrates how steeply the seam dips into the valley side.

**Figure 8** Seam dipping into the valley side

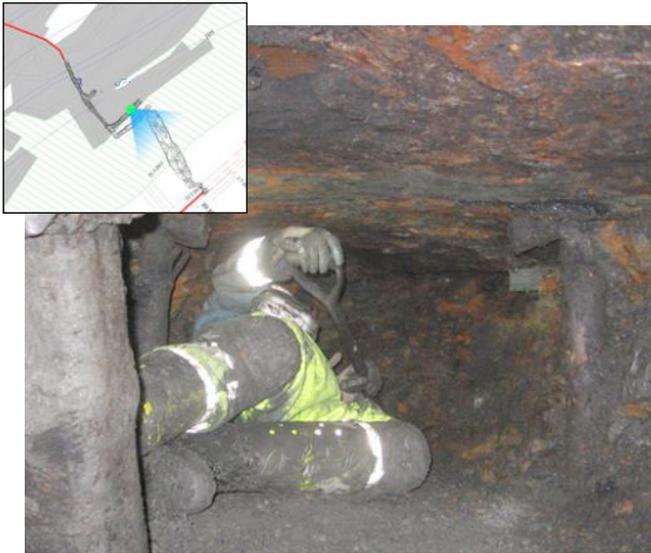
**Figure 16** Mines rescue workers tunnel through the stone pack in the Old Central Workings to gain access to the breach from the opposite side to the inrush stall

to the Top Road. On Monday of the third week, a section of the pack from the bottom roadway in the Old Central Workings was removed as a way of quickly gaining access to the top of the inrush stall. Investigators were now therefore able to gain access to the inrush stall from both the top and bottom.

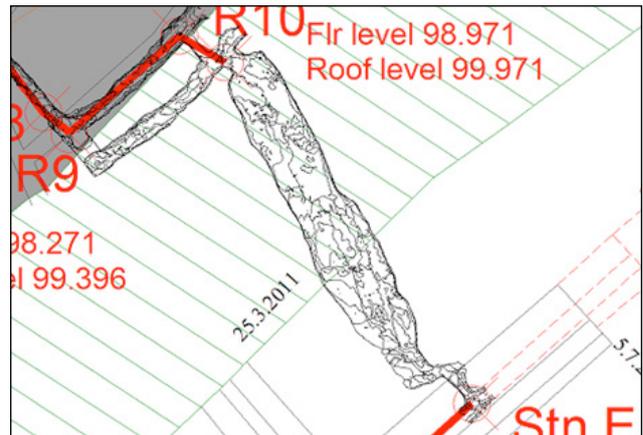
131 Figure 19 shows all of the inrush stall. The narrow 'dog leg' at the bottom is the way in excavated by rescuers and investigators to gain access. The stall would have been an almost constant width before the inrush, but silt and debris filled all of most of the bottom end of it after the inrush. The laser scanner could only measure the limits of the silt and debris rather than the edges of the original excavation in this part.

**Figure 19** The laser scan showing all of the inrush stall

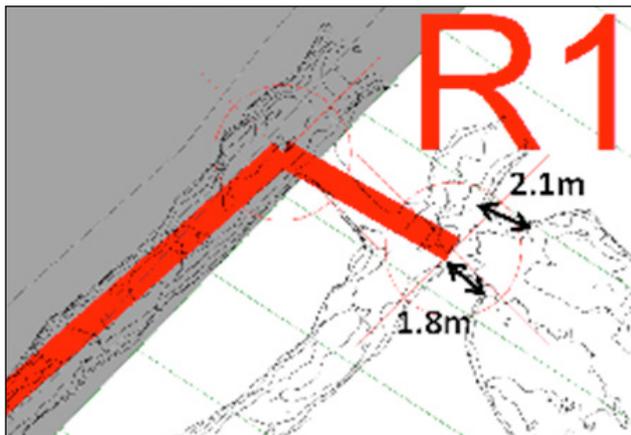
132 Figures 20 and 21 show the laser scan of the top of the inrush stall, the breach into the Old Central

Workings and parts of those workings. The laser scanned parts of the Old Central Workings show the edge of the bottom-most working precisely correlating with the edge of the excavation shown on the mine plan, which is denoted by the grey shading. The laser-scanned open space running more or less parallel to this is the actual extent of the coal excavated from the Old Central Workings in the 1980s. The black lettering shows the distance through the breach between the top of the inrush stall and the edge of the Old Central Workings.

**Figure 20** The laser scan of the top of the inrush stall and the bottom of the Old Central Workings

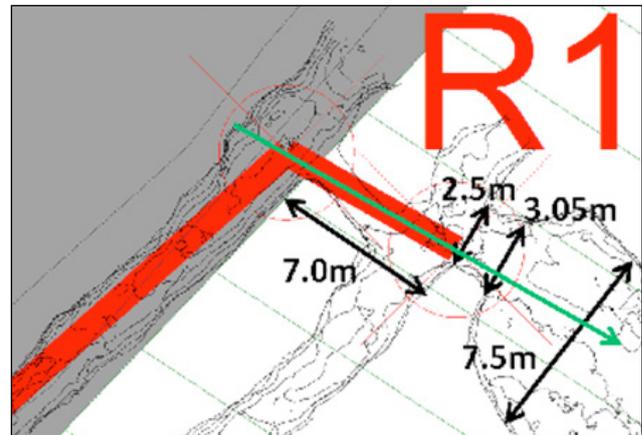
133 In Figure 21, the distance arrow of 7.0 m shows the distance between what was shown as the edge of the workings on the mine plan and the actual edge of these old workings surveyed and scanned during the investigation. The white space between them contains the stone pack built during the 1980s. The laser-scanned area between them (under the short red line) is the tunnel dug through the stone pack by investigators. The other distance arrows are as follows: 7.5 m – the width of the top of inrush stall; 3.05 m – the width of the breach on the inrush stall side; 2.5 m – the width of the breach on the Old Central Workings side.

**Figure 21** Arrows showing the measurements after the area was surveyed and scanned
