Investigation report

Report into the deaths of James Mitchell and
Phillip Grant at the Austar Coal Mine,
Paxton, NSW on 15 April 2014

Report prepared by the NSW Mine Safety
Investigation Unit

October 2015

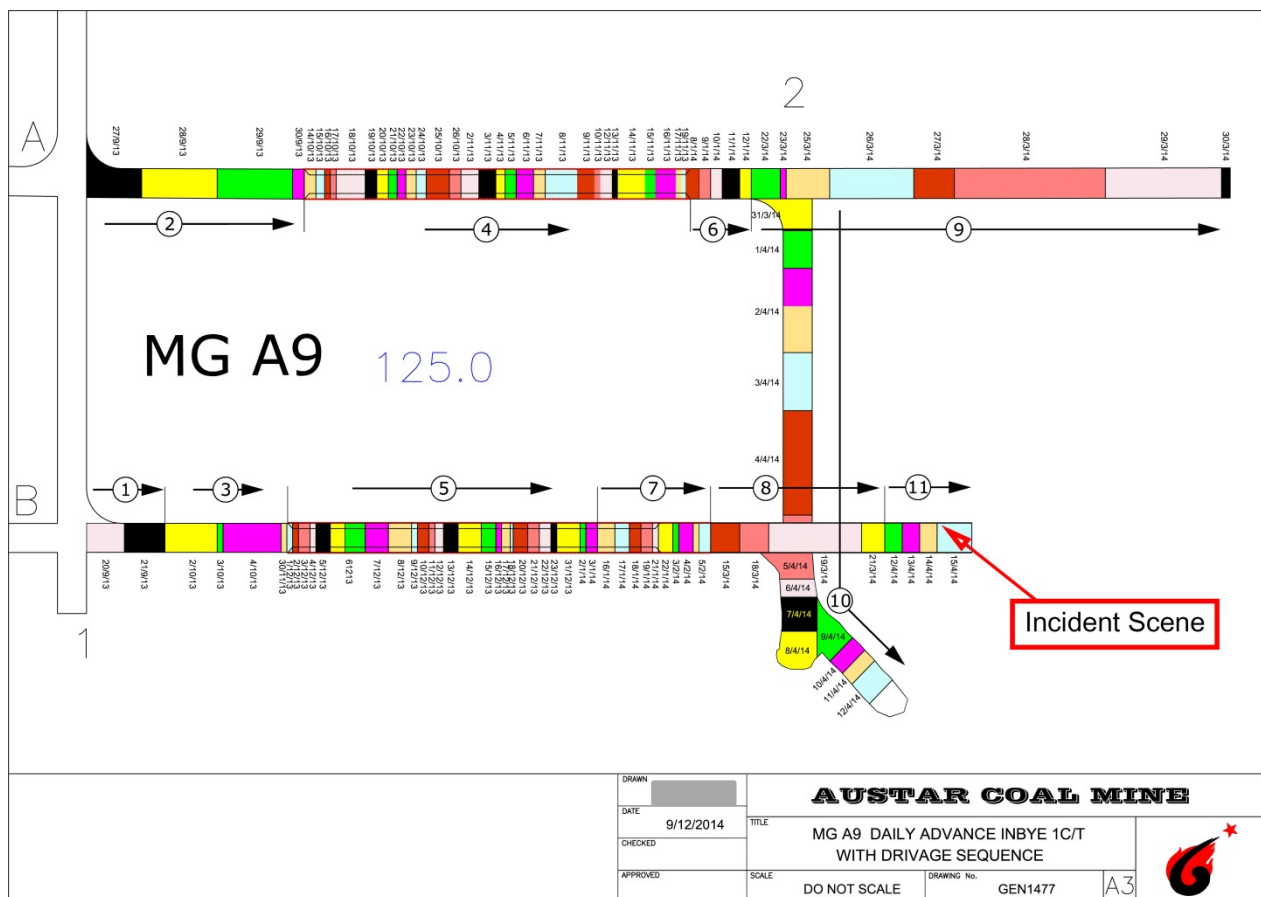
Development in MG A9 began in September 2013. Figure 5 below depicts the location of the face of MG A9 at the end of every shift up to the time of the incident. As can be seen below, it took Austar approximately four months to advance 1 cut-through.

Figure 5 MG A9 daily drirage inbye 1C/T with drirage sequence. ⁴⁰

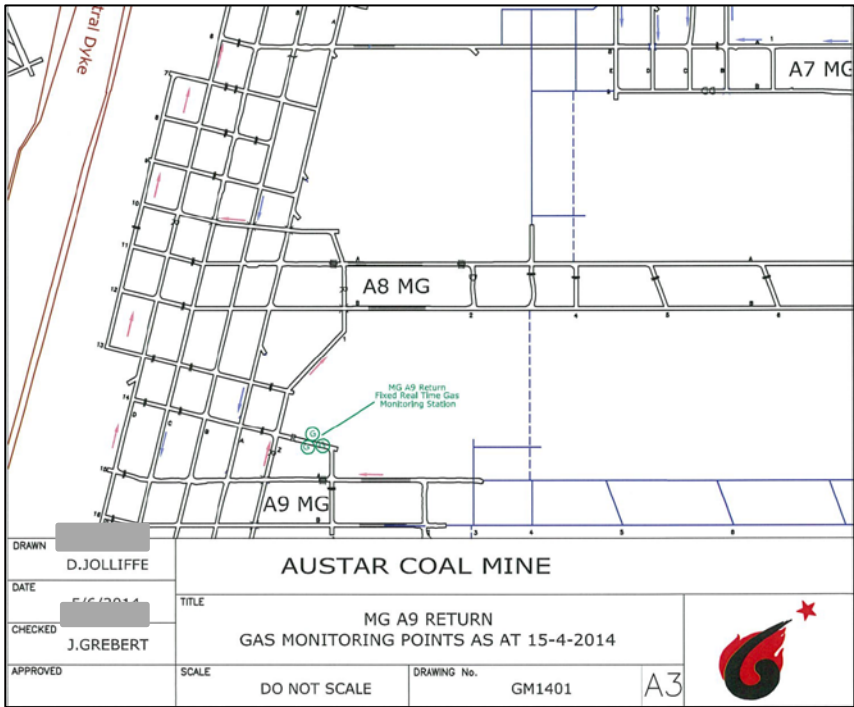
Figure 16 below shows the location of the fixed real time monitors in the return airways at the outbye end of MG A9. Data from these monitors and from the tube bundle monitoring point 13 located outbye at the up-cast shaft, show relatively low and constant levels of CO₂ and CH₄ before, during and after the incident.

Figure 16 Austar Coal mine MG A9 gas monitoring points.⁷⁰

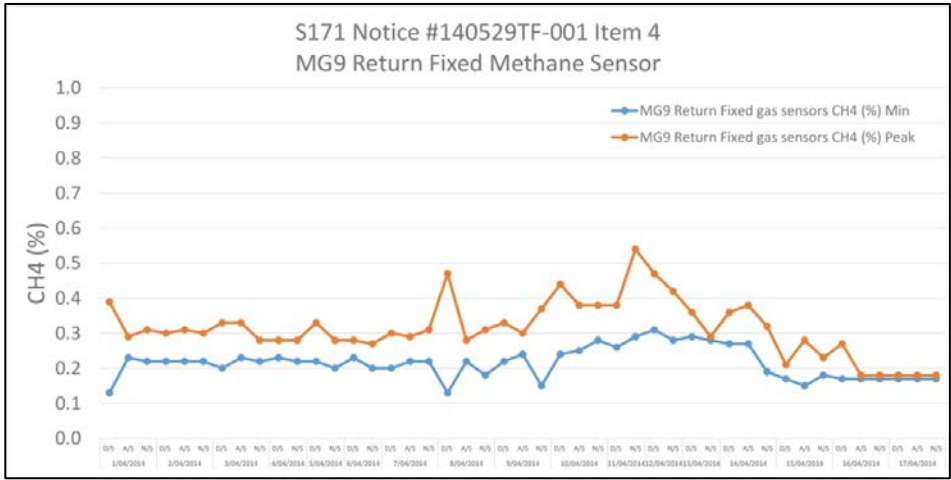
Figures 17, 18, 19 and 20 below graph the readings of CH₄, CO₂ and O₂ outbye of MG A9 for the period from 1 April 2014 through to 17 April 2014. As can be seen, there are no elevated readings or unusual spikes within the outbye gas monitoring system.

Figure 17 MG A9 return fixed methane sensor.⁷¹

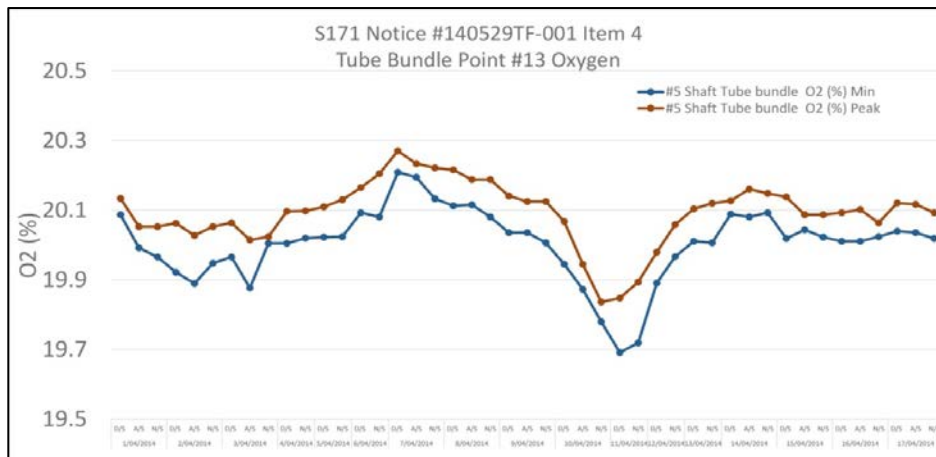
Figure 18 Tube bundle point 13 Oxygen.⁷²

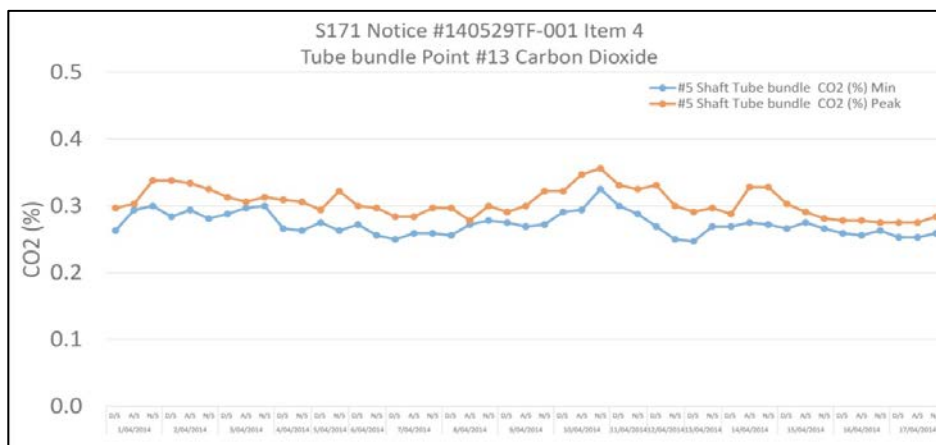
Figure 19 Tube bundle point 13 Carbon Dioxide.⁷³

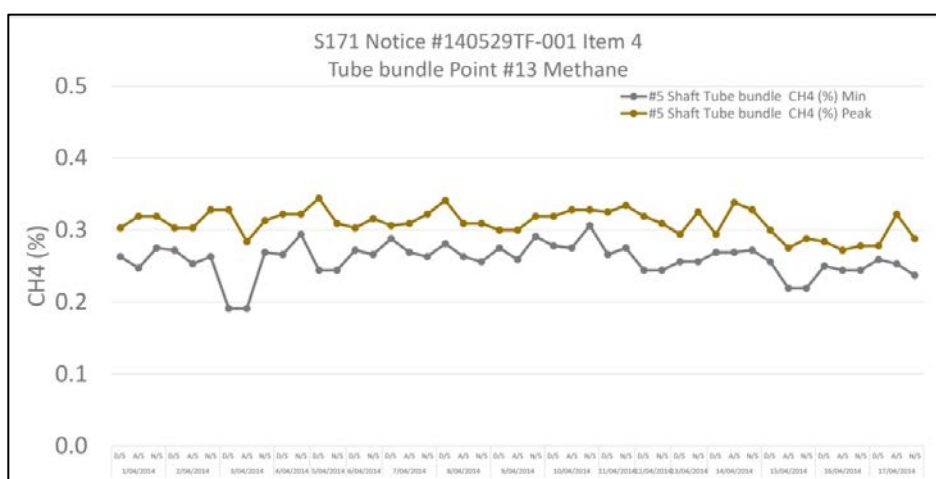
Figure 20 Tube bundle point 13 Methane.⁷⁴

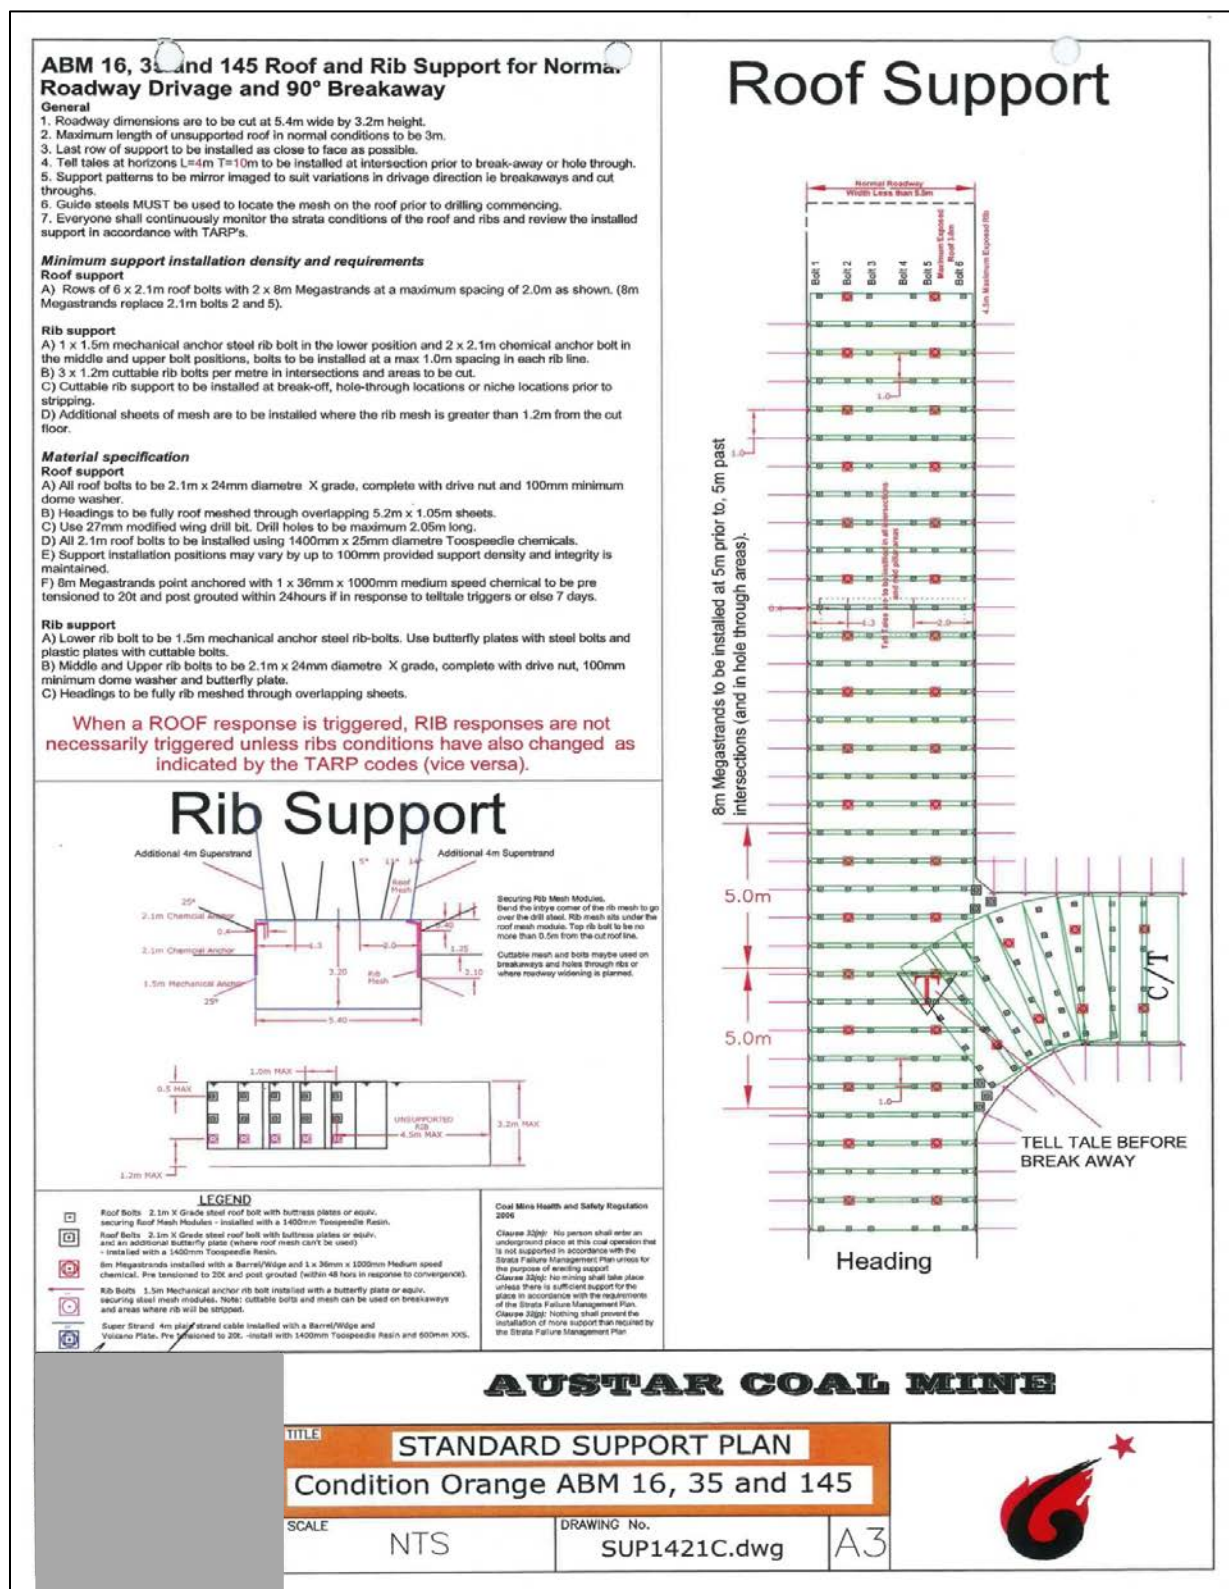
At the time of the incident, the ribs were being supported to a standard set out in the mine's roadway support rules. The required standards for supporting the rib and roadway in the mine are shown below in Figures 21 and 22.

Figure 21 Condition orange standard support plan.⁷⁶

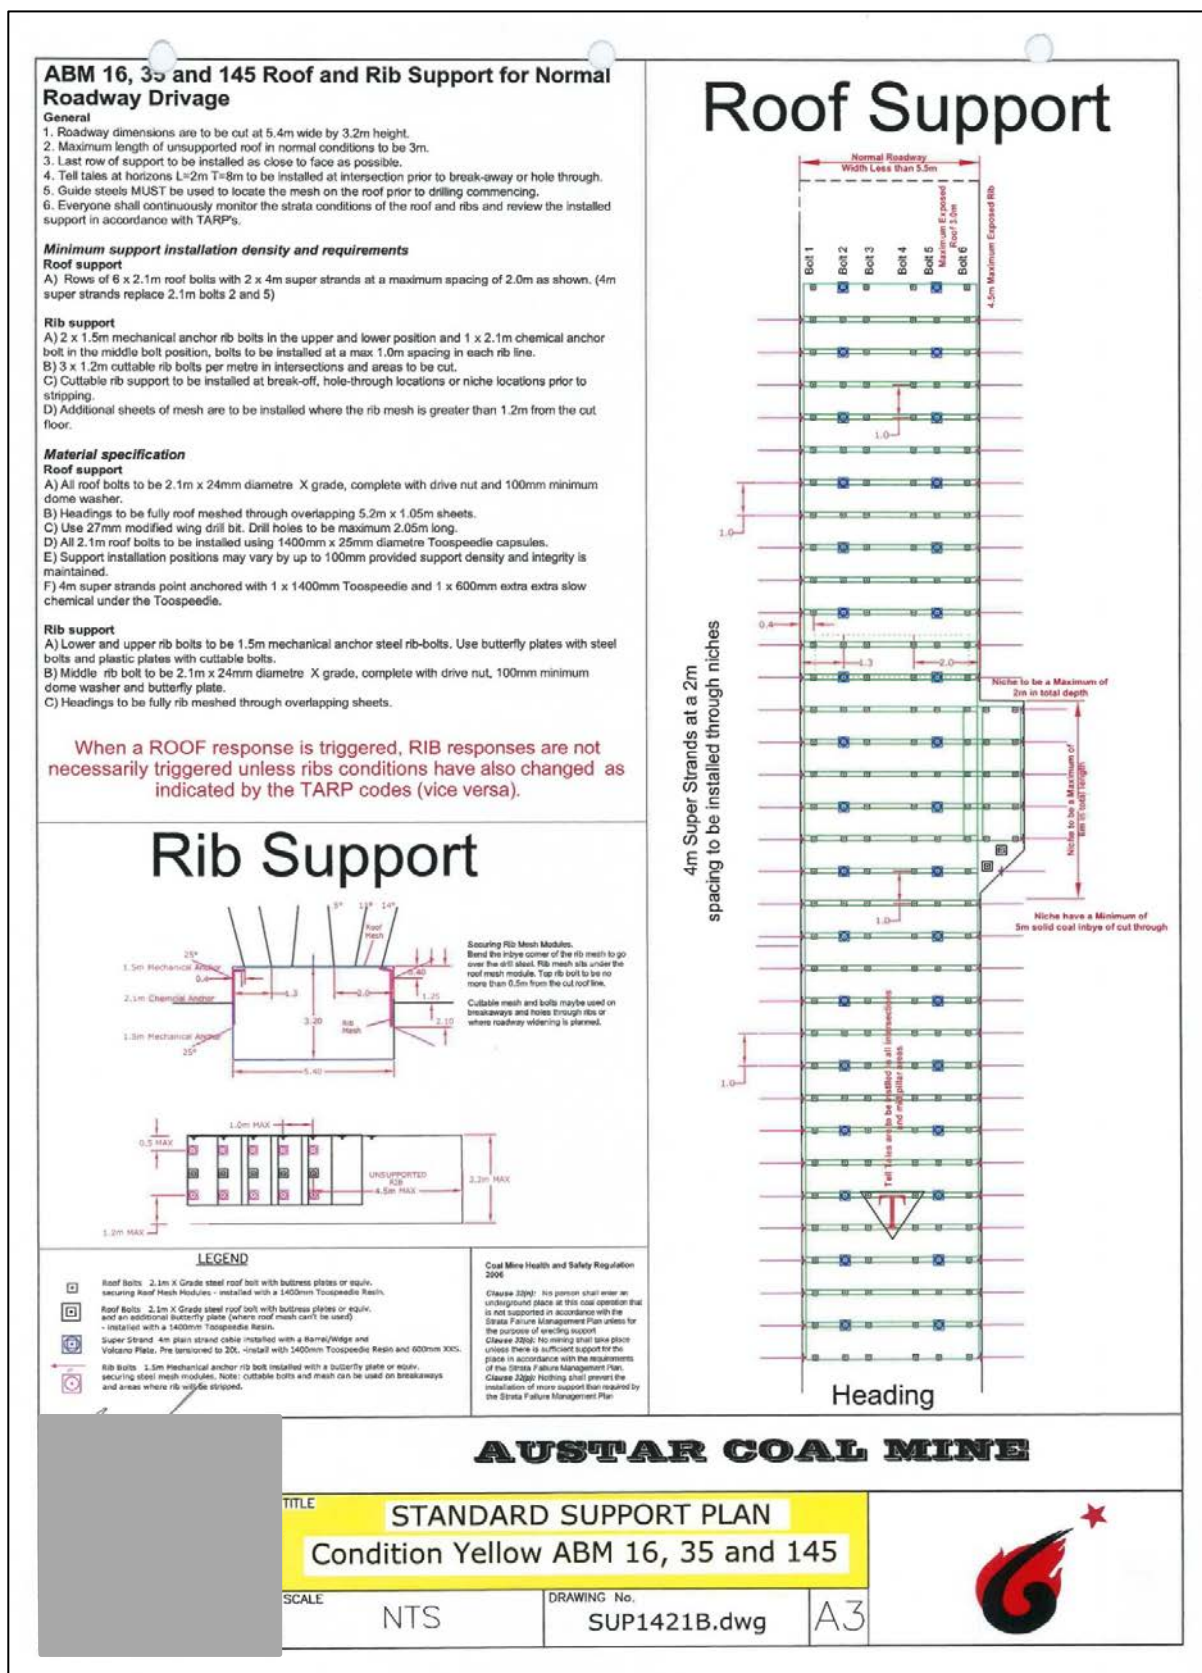
Figure 22 Condition yellow standard support plan.⁷⁷

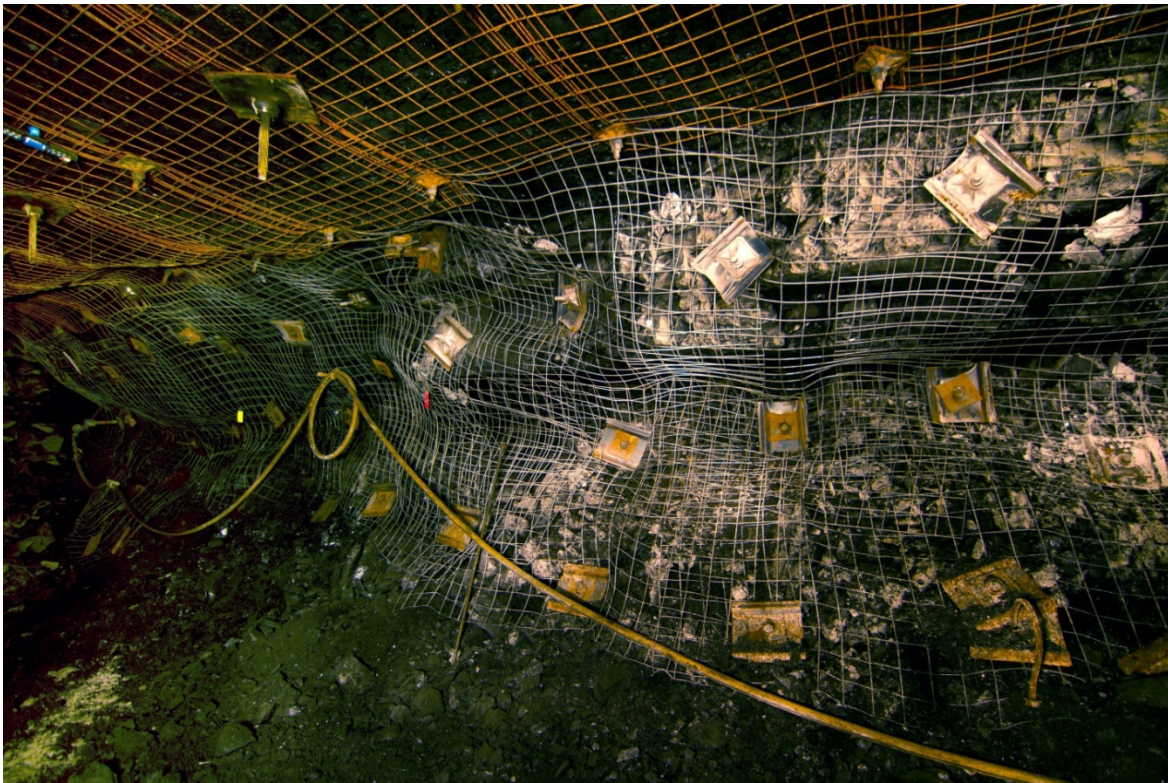
Due to the soft broken nature of the ribs at Austar it was common for the operators of the bolting rigs to encounter problems when setting the rib supports. All operators spoken to insisted that if a chemical or mechanical anchor was not properly secured, a new bolt would be installed next to it. This contention is supported by observation of the support outbye of the incident as demonstrated in Figure 24 below.

Figure 24 Example of bolting in the adjacent A Heading of MG A9.
