**NSW
Resources
Regulator**

INVESTIGATION REPORT

REPORT INTO THE DEATH OF MR QUINTON MOORE

Bengalla mine on 3 November 2018

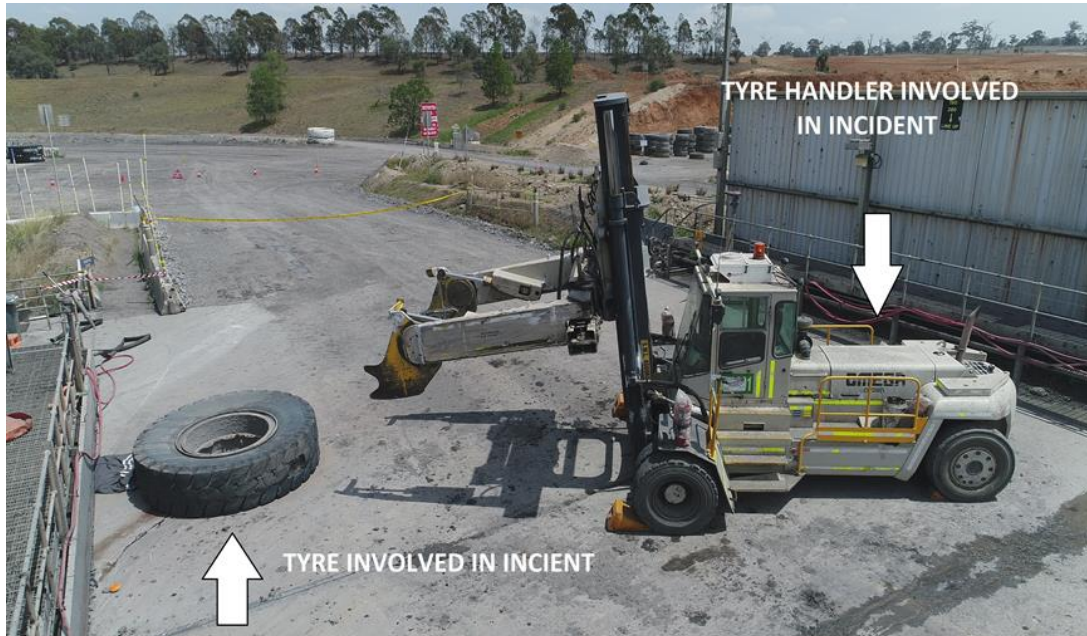
Figure 3 Omega tyre handler THL001

The plant involved in the incident was an Omega lift truck model 16-12TH, designed and manufactured by Clark. It was fitted with an attached 16 – 1200 tyre handler model 176HDT21I (refer to figure 3) which was designed and manufactured by Cascade. The lift truck was identified by the mine as THL001. The tyre handler is owned by the mine and was purchased from Clark in 2005.

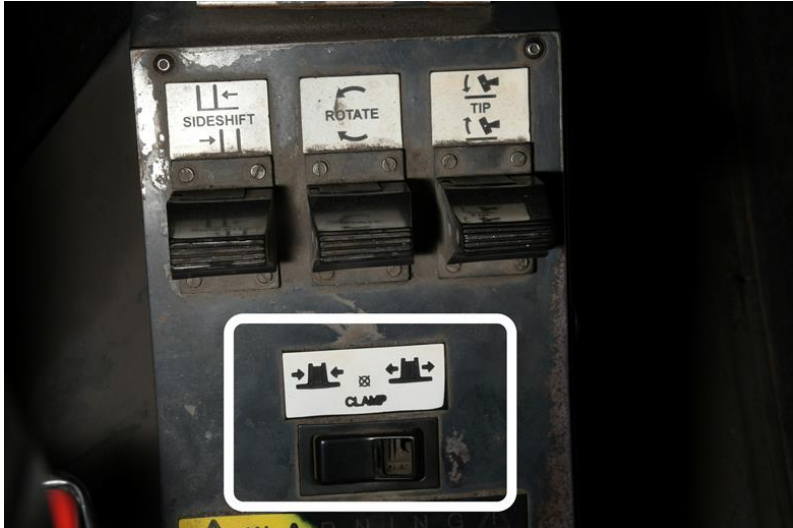
Figure 4 Clamp control in THL001

The clamp control button is spring loaded (refer to figure 4). Depressing the left side will clamp the tyre (refer to figure 5) and depressing the right side will release the tyre (refer to figure 6). The minimum distance between the grabs is 1450 millimetres and the maximum distance is 4500 millimetres. The only method available for operators to ensure a tyre was securely maintained in the grabs were visual cues observing bulges in the side wall of tyres.

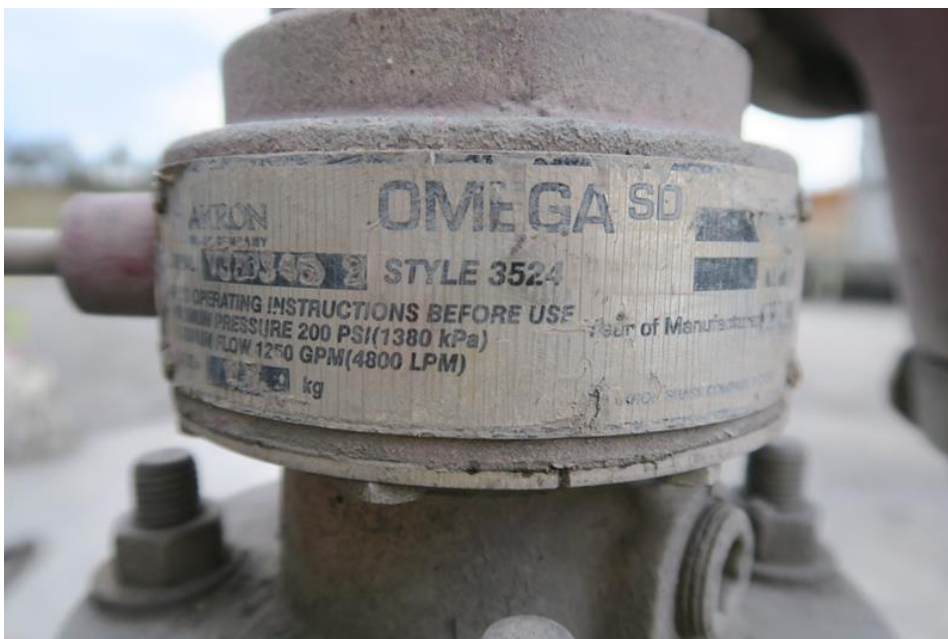
Figure 11 water cannon operating instructions

There was no specific induction for workers to operate the cannons despite the following warning, 'Read operating instructions before use'.

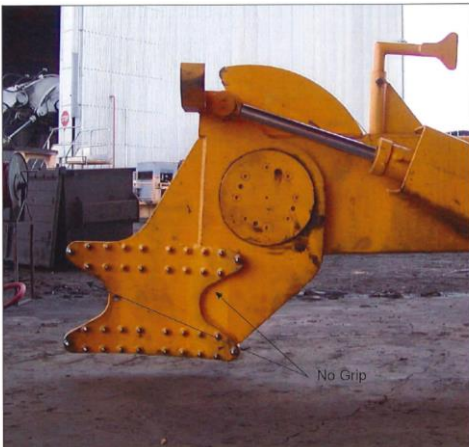
Figure 19 Photo depicting current OEM design

The investigation identified that neither the mine nor Marathon Tyres were aware of the report. In examining the security of tyres while being manoeuvred, one of the study's objectives was to increase the security of the tyre grip, especially while the tyre was maintained in the vertical position. Figure 19 represents the current OEM design at the time of the report, which the authors claimed lacked sufficient tyre surface grip.

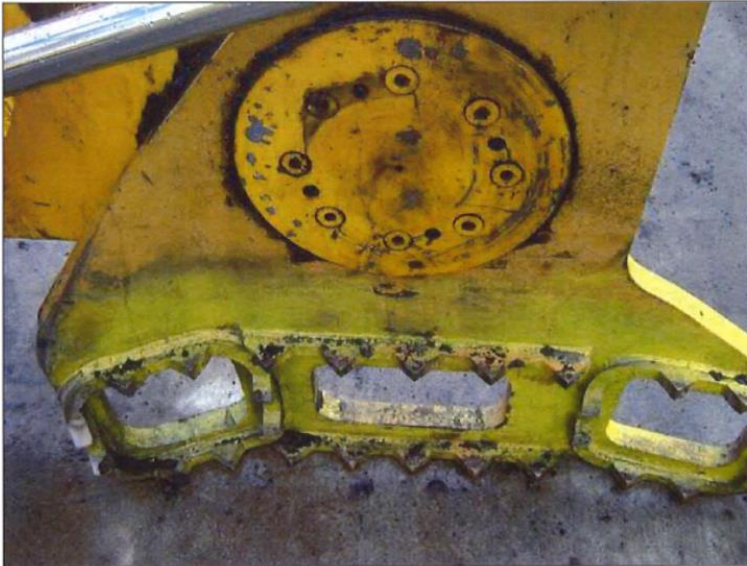
Figure 24 Modified grab hand

Two issues were identified by tyre handlers, regarding reduced capability to rotate smaller tyres when remounting, and issues accessing the tyre when obstructed by guards and/or mud flaps. This resulted in minor modification to the new grab design, reducing the grab hand by 310 millimetres while maintaining the increased tyre grip design feature (refer to figure 24).

Recommendation 1 of the report concluded ‘The revised grab jaws have proved to be very effective in reducing slippage of tyres during tyre-changing operations over a wide range of tyre sizes. It is recommended that efforts now be made to commercialise it.’
