Discussion Paper

Safety of Persons in Proximity to Underground Coal Mine Openings

Prepared by: Mark Parcell.
Mark@MineSafetyInstitute.com.au
www.minesafetyinstitute.com.au
17th of June 2014.

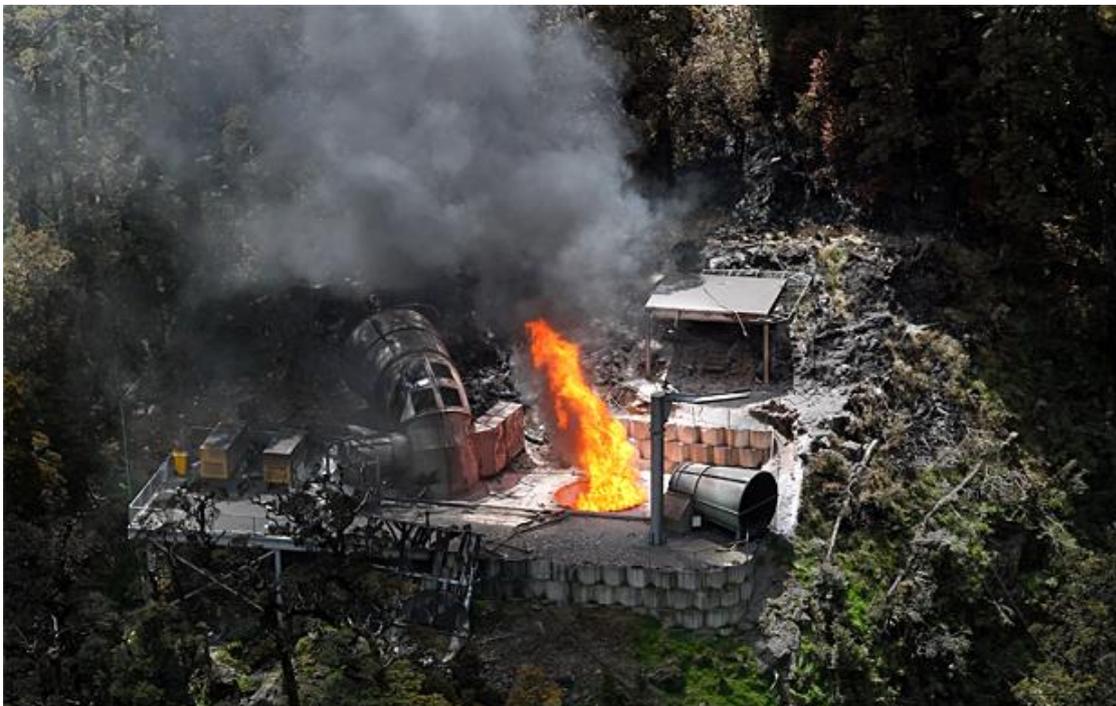
Figure 8.10: The surface fan after the first explosion

Despite rescuers not entering the mine following the initial explosion on the 19th of November 2010, rescue workers were in close proximity of mine openings and further fatalities were lucky not to occur during subsequent explosions. Figure 8.10 from Volume 2 of the Pike River Royal Commission Report² (below) shows three men standing in close proximity to the return shaft at Pike River (and another person taking the photo), already damaged by the first explosion.

The shaft collar area and infrastructure was subsequently destroyed by additional explosions. It was only luck that rescuers were not in the area at the time of subsequent explosions. [Video footage of the 4th Pike River explosion.](#)

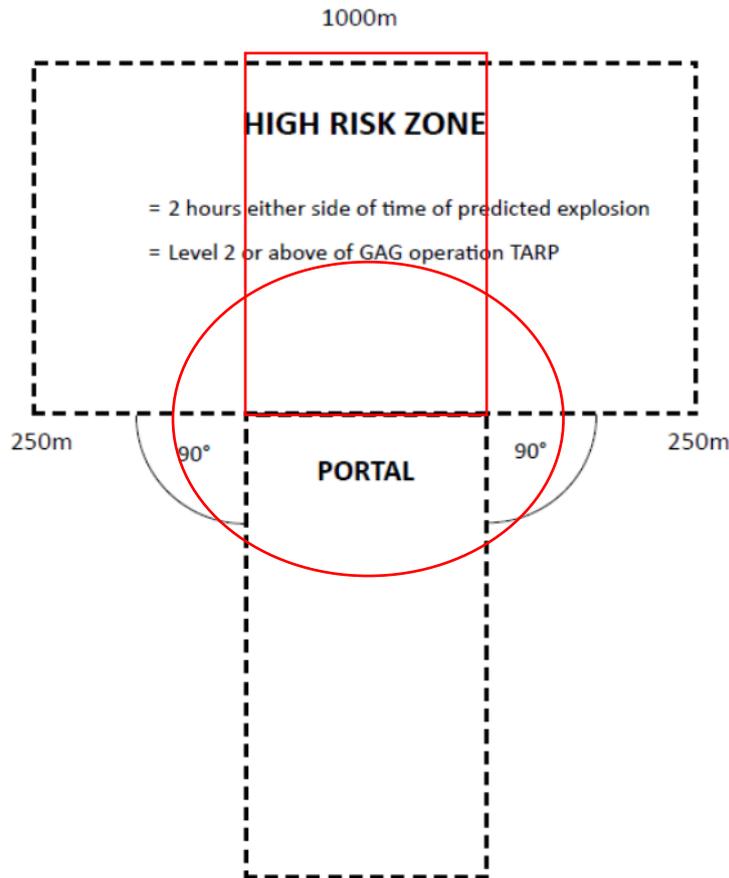
In 2008, the Queensland Chief Inspector of Coal Mines required QMRS to demonstrate that GAG operations were being undertaken in a place of safety¹³. Following industry consultation QMRS established High Risk Zones around mine entrances for GAG operations. These zones are defined in the QMRS GAG Operating Guidelines (JIU0056CD Revision 6 24 April 2013). High risk zones are established around mine portals and shafts, but only for GAG operations. The unfortunate part about this is that the explosion risk is most likely present well before the GAG operations are likely to commence. The high risk zones are described and diagrammatically represented in the QMRS GAG Operating Guideline.

Without scientifically or critically analysing the dimensions of the high risk zones, based on information from the review of historical events, the zone dimensions appear adequate. The only point for consideration is that the diagram is disproportional and potentially misleading. It is twice as long as it is wide, but this is not represented in the diagram. The portal width is excessive and the location of the 1000m distance is potentially confusing. It is recommended that the QMRS update this diagram in order to reduce any potential confusion. It is also recommended that the industry adopt this standard as an interim industry standard.

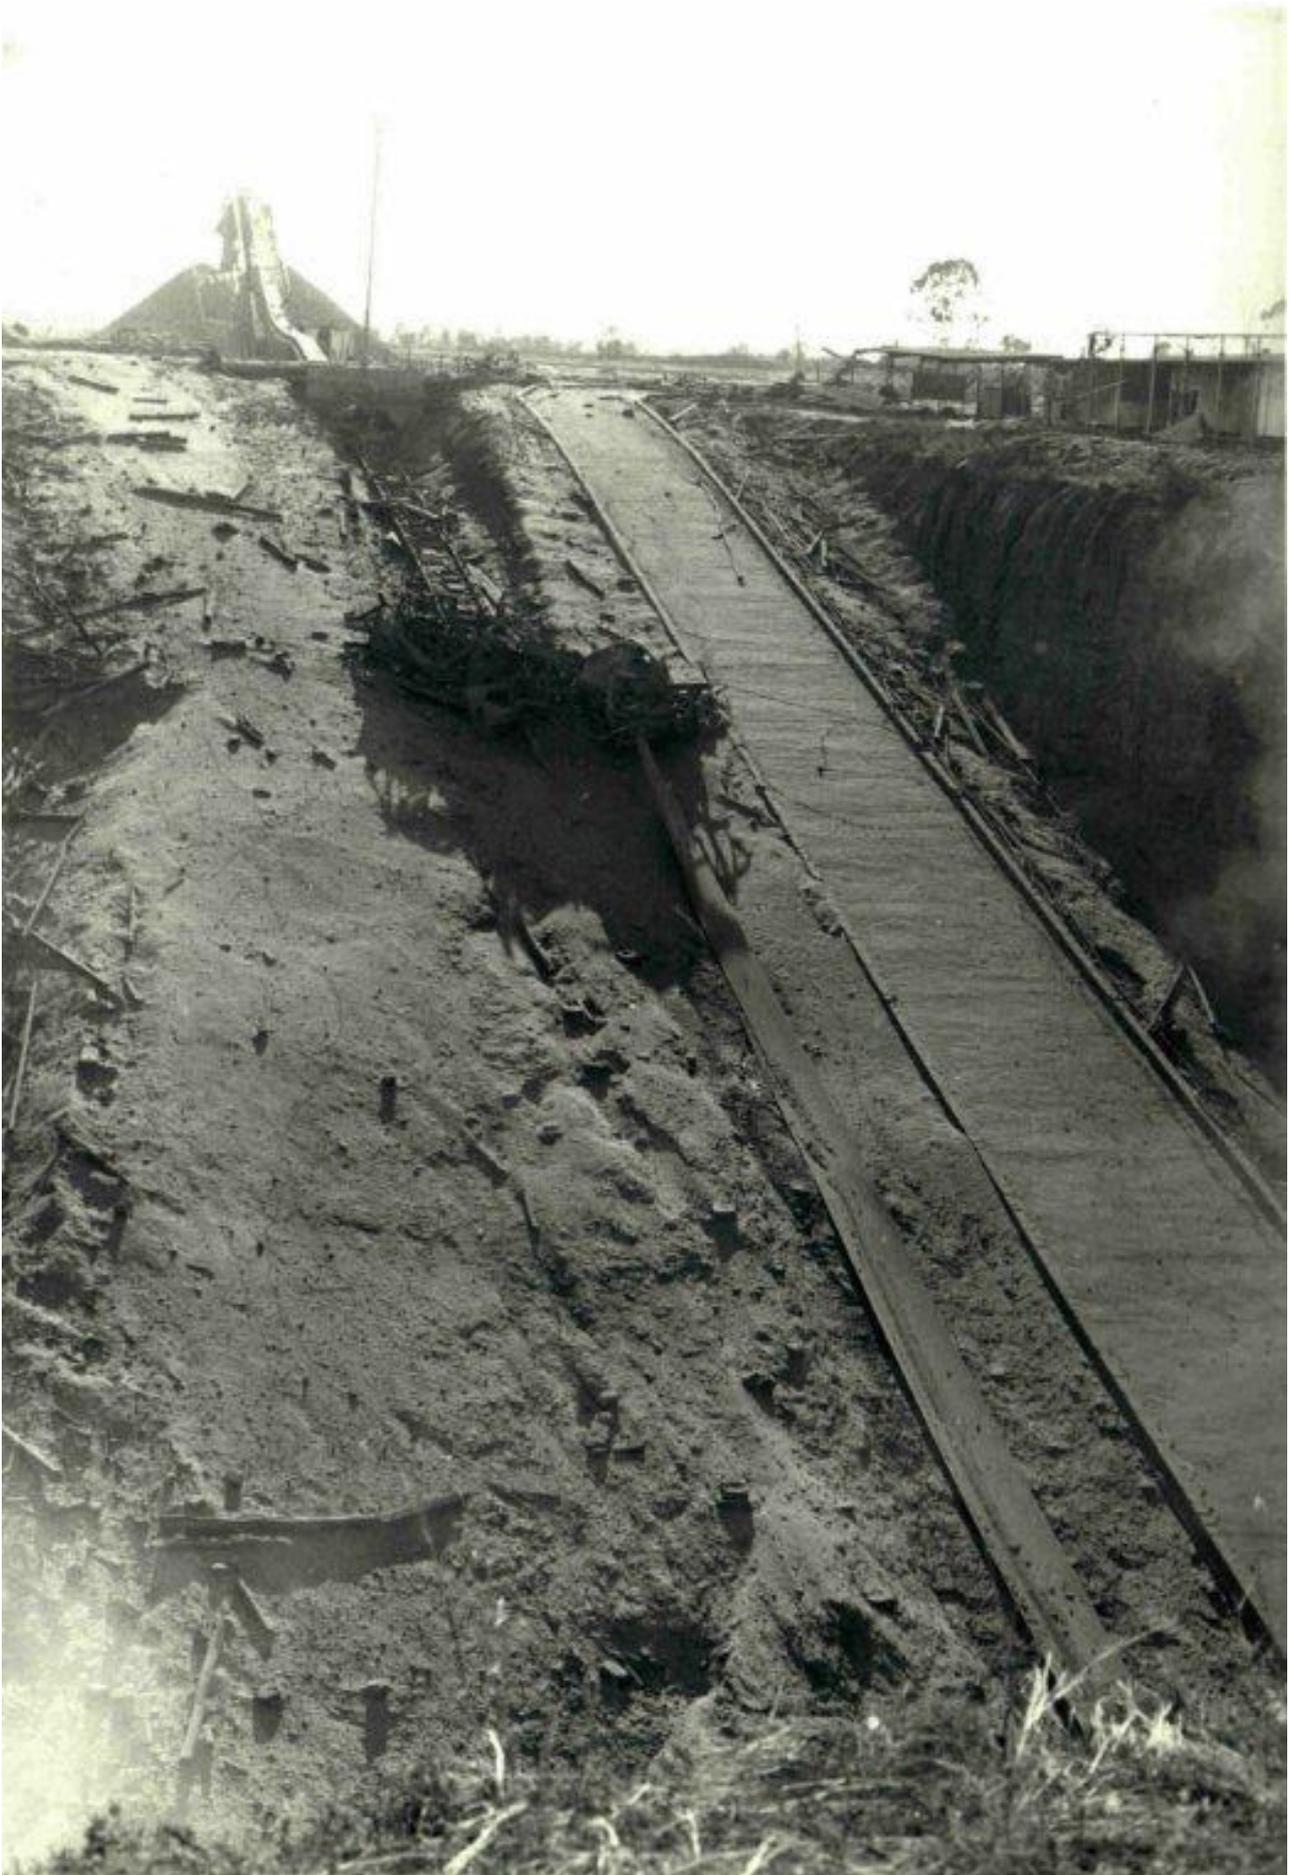
West Wallsend, NSW, 8th of January 1979.

In January 1979 surface infrastructure was severely damaged in the West Wallsend mine explosion. Fortunately no one was killed in the explosion, either on the surface or underground. However, significant infrastructure damage occurred.

| <p>(f) Where possible mine surface buildings should be positioned out of the direct path of any underground explosion.</p> |
