# Report reveals how the death of Connor Milne at Fairfield Quarry could have been avoided

Direct factors that led to the death of 21-year-old Connor-Shaye Campbell Milne at Fairfield Quarry at Clermont in 2018 have been revealed in a report released by Resources Safety and Health Queensland.

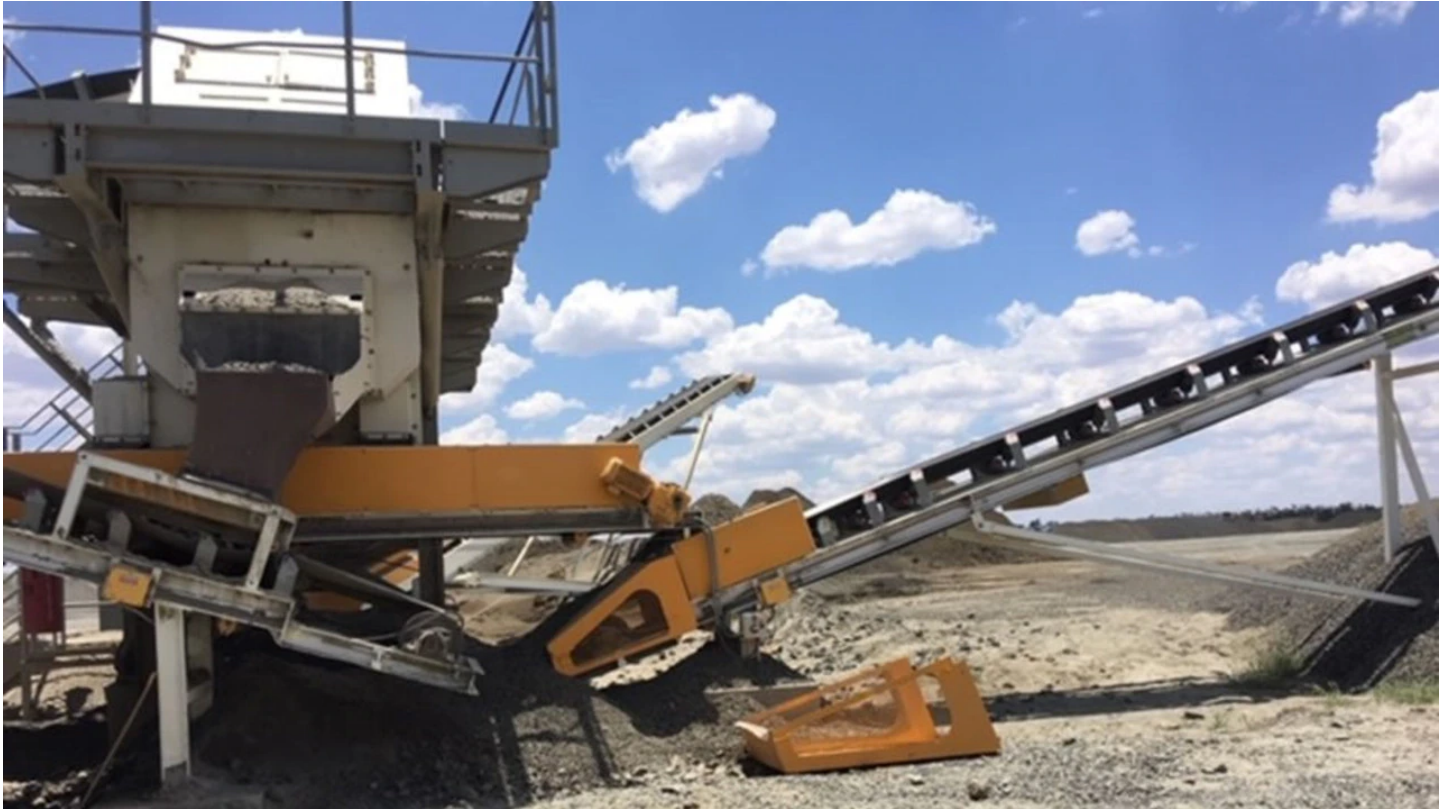
A conveyor at Fairfield Quarry, Clermont.
