Elastic springback in plates on equipment

Mines safety bulletin no. 172 | 27 June 2018 | Version 1

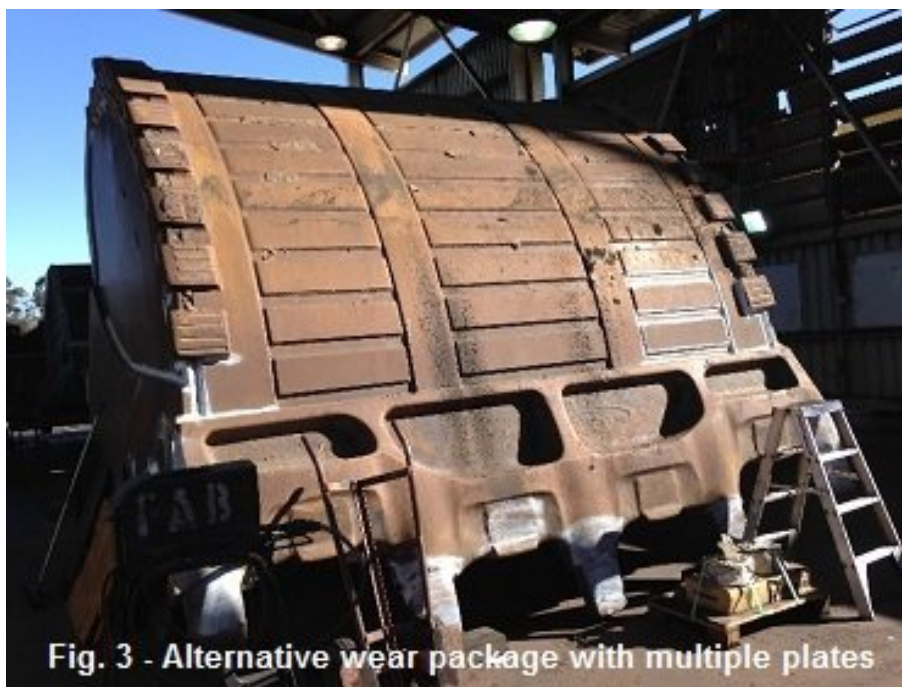
Fig. 3 - Alternative wear package with multiple plates

The original design had much less springback potential because using several wear plates instead of one large one will reduce the amount of stored energy that has to be controlled at any one time during removal. (Compare Fig. 3 with Fig. 1B)

In general, for the purposes of controlling elastic springback potential, designs with multiple smaller wear plates are recommended.
